## General Information

| Make | Toyota | Model | Avanza |

## Body / Panel Condition

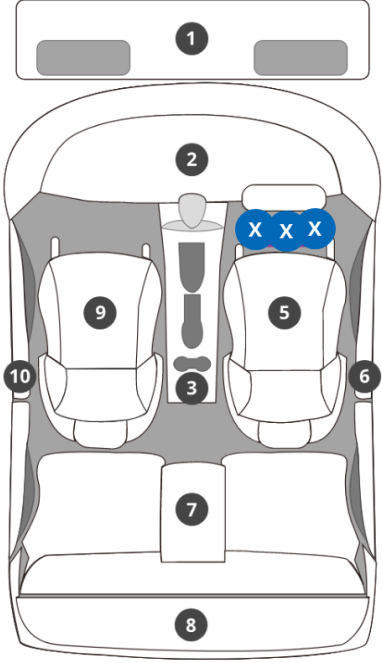
| Interior Evaluation : <b>B</b> | Exterior Evaluation : <b>E</b> |
| <p><b>Remarks</b><br/>(L) Front Floor Mat - Missing - Yes / (R) Front Floor Mat - Missing - Yes / Mat Other - Missing - Yes</p> | <p><b>Remarks</b><br/>Bonnet, Headlight - Scratch - Small / Rear Bumper, Lamps, Panels - Scratch - Large / (R) Step, In-panel, Side Spoiler - Scratch - Large / (R) Mirror - Scratch - Medium / Front Bumper, Grille, Lamps - Scratch - Medium / Roof - Scratch &amp; Dent - Small / (R) Front Fender, Molding - Dent - Small / (L) Rear Door, Molding - Scratch - Small / (L) Front Door, Molding - Scratch - Small / (R) Front Door, Molding - Scratch - Small / (L) Rear Fender, Molding - Scratch - Small / (R) Rear Door, Molding - Scratch - Small / Trunk Hood, Rear Gate - Scratch - Small</p> |

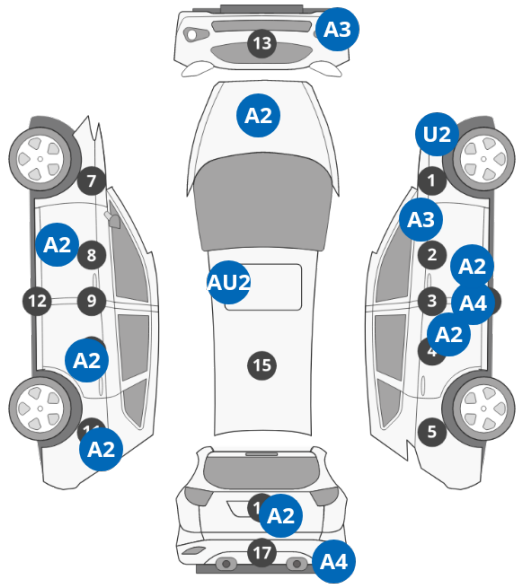
| Inspector Notes |
|---|
| light scratches around the exterior/ no jack and tools/ possible flooding/with spare tire and warranty booklet/ with LTO plate/ |
