## General Information

| Make | Toyota | Model | Raize |

## Body / Panel Condition

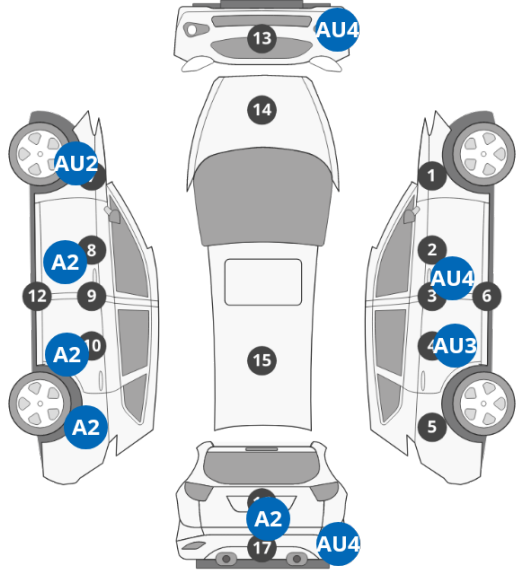
| Interior Evaluation : <span style="color: red; font-weight: bold;">A</span> | Exterior Evaluation : <span style="color: red; font-weight: bold;">D</span> |
|---|---|
| <b>Remarks</b><br>Defects not found | <b>Remarks</b><br>(R) Front Door, Molding - Scratch & Dent - Large / Front Bumper, Grille, Lamps - Scratch & Dent - Large / (R) Rear Door, Molding - Scratch & Dent - Medium / Rear Bumper, Lamps, Panels - Scratch & Dent - Large / (L) Front Fender, Molding - Scratch & Dent - Small / (L) Rear Fender, Molding - Scratch - Small / (L) Rear Door, Molding - Scratch - Small / Trunk Hood, Rear Gate - Scratch - Small / (L) Front Door, Molding - Scratch - Small |

no jack and tools/ light scratches around the exterior/possible flooding/ temporary ORCR/with spare tire and LTO plate/ with warranty booklet/
