## General Information

| Make | Toyota | Model | Vios |

## Body / Panel Condition

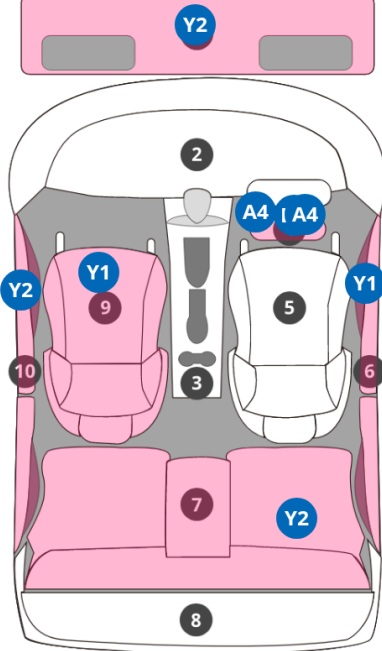
| Interior Evaluation : <b>C</b> | Exterior Evaluation : <b>E</b> |
| <p><b>Remarks</b><br/>Ceiling - Grime - Small / Rear Seat - Grime - Small / (R) Front Trim - Grime - Minimal / (R) Front Floor Mat - Worked - Small / (L) Front Trim - Grime - Small / (L) Front Seat - Grime - Minimal / (L) Front Floor Mat - Cut, Crack - Large / Carpet - Worn, Scratch, Cut, Crack - Large</p> | <p><b>Remarks</b><br/>(L) Front Fender - Repair Traces - Yes / (R) Front Fender, Molding - Scratch &amp; Dent - Small / (R) Mirror - Scratch - Minimal / (R) Front Door, Molding - Scratch &amp; Dent - Small / (R) Step, In-panel, Side Spoiler - Scratch &amp; Dent - Large / (R) Rear Door, Molding - Scratch - Small / Rear Bumper, Lamps, Panels - Scratch &amp; Dent - Medium / Trunk Hood, Rear Gate - Scratch &amp; Dent - Medium / (L) Rear Fender, Molding - Scratch &amp; Dent - Medium / (L) Rear Door, Molding - Scratch - Small / (L) Front Door, Molding - Scratch - Medium / (L) Step, In-panel, Side Spoiler - Scratch - Small / Roof - Scratch - Large / (L) Mirror - Scratch - Minimal / (L) Front Fender, Molding - Repair mark - Yes / Roof Spoiler, Molding - Scratch - Small / (L) Front Fender, Molding - Scratch - Minimal / Front Bumper, Grille, Lamps - Scratch - Small / Bonnet, Headlight - Scratch - Small / (R) Rear Fender, Molding - Scratch - Small / (R) Rear Tyre - Crack, Cut - Yes</p> |

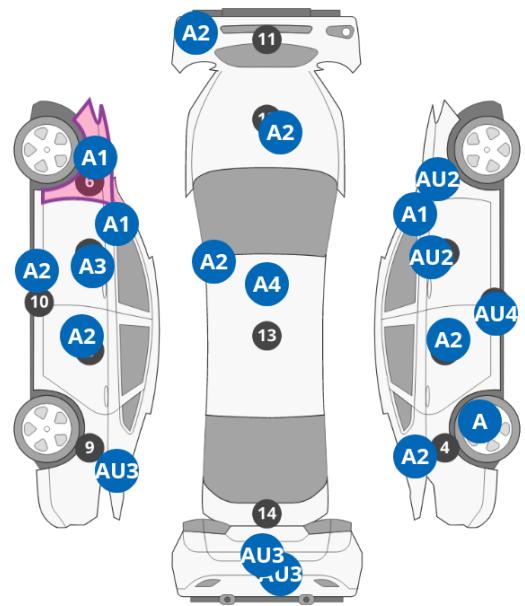
| Inspector Notes |
|---|
| With Lto plate, with warranty booklet, 2 keys, no spare tire and jack and tools, scratches on headlights and taillights, worn front tires, visible hairlines scratches and stains on vehicle, carpet issue |
