## General Information

| Make | Toyota | Model | Wigo |

## Body / Panel Condition

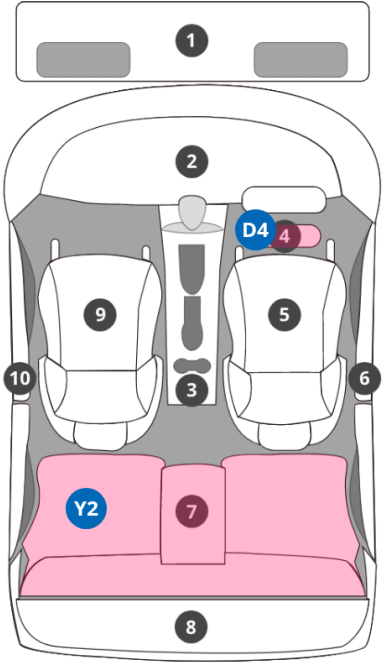
| Interior Evaluation : <span style="color: red;">C</span> | Exterior Evaluation : <span style="color: red;">E</span> |
| <b>Remarks</b><br>(L) Front Floor Mat - Worked - Large / Rear Seat - Grime - Small | <b>Remarks</b><br>(R) Front Fender - Repair Traces - Yes / (R) Rear Door, Molding - Scratch - Small / (R) Rear Door, Molding - Repair mark - Yes / Front Bumper, Grille, Lamps - Crack, Gap - Large / (L) Front Fender, Molding - Dent - Small / (L) Step, In-panel, Side Spoiler - Scratch & Dent - Medium / Roof Spoiler, Molding - Dent - Small / Rear Bumper, Lamps, Panels - Scratch - Medium / (R) Step, In-panel, Side Spoiler - Scratch & Dent - Medium / (R) Rear Fender, Molding - Scratch - Small / (R) Front Door, Molding - Scratch & Dent - Small / (R) Front Fender, Molding - Scratch - Small / Bonnet, Headlight - Scratch - Medium / Roof - Scratch - Small |
