## General Information

| Make | Toyota | Model | Vios |

## Body / Panel Condition

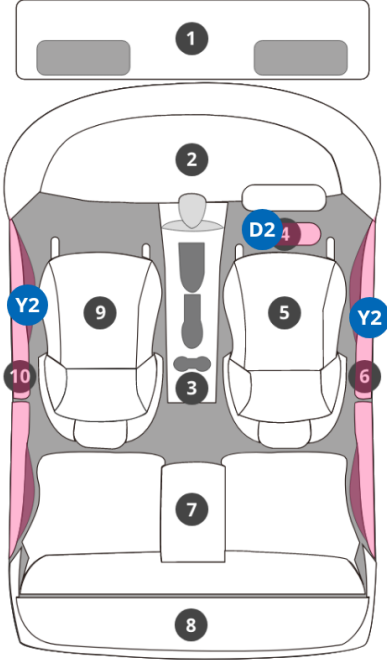
| Interior Evaluation : <b>A</b> | Exterior Evaluation : <b>D</b> |
| <b>Remarks</b><br>(L) Front Trim - Grime - Small / (R) Front Trim - Grime - Small / (L) Front Floor Mat - Worked - Small | <b>Remarks</b><br>Rear Bumper, Lamps, Panels - Crack, Gap - Medium / (L) Rear Door, Molding - Scratch & Dent - Large / (L) Rear Fender, Molding - Scratch - Small / Front Bumper, Grille, Lamps - Scratch & Dent - Large / (R) Front Fender, Molding - Scratch - Minimal / (R) Front Door, Molding - Scratch - Small / (R) Rear Door, Molding - Scratch - Small / Trunk Hood, Rear Gate - Scratch - Small / (L) Front Door, Molding - Scratch - Small / (R) Rear Fender, Molding - Scratch - Minimal / (L) Front Fender, Molding - Scratch - Minimal / Roof - Scratch - Minimal / Bonnet, Headlight - Scratch - Small |
