## General Information

| Make | Toyota | Model | Vios |
| Registration No. | CCA8189 | Chassis No. | PA1B18F30R4257949 |

## Body / Panel Condition

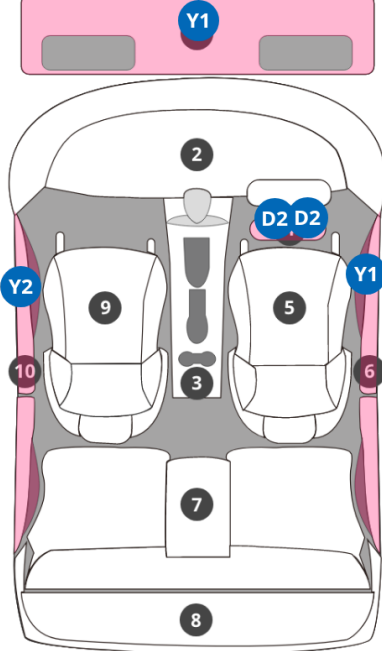
| Interior Evaluation : <span style="color: red;">A</span> | Exterior Evaluation : <span style="color: red;">C</span> |
|---|---|
| <b>Remarks</b><br>Ceiling - Grime - Minimal / (R) Front Trim - Grime - Minimal / Mat Other - Worked - Small / (L) Front Trim - Grime - Small / (L) Front Floor Mat - Worked - Small | <b>Remarks</b><br>(R) Front Fender - Repair Traces - Yes / (R) Rear Fender - Repair Traces - Yes / (R) Front Fender, Molding - Repair mark - Yes / (R) Front Door, Molding - Scratch - Minimal / (R) Rear Door, Molding - Scratch - Minimal / (R) Rear Fender, Molding - Repair mark - Yes / (R) Rear Fender, Molding - Scratch - Minimal / Rear Bumper, Lamps, Panels - Scratch - Minimal / Trunk Hood, Rear Gate - Scratch - Minimal / (L) Rear Fender, Molding - Scratch - Minimal / (L) Rear Door, Molding - Scratch - Minimal / (L) Front Door, Molding - Scratch & Dent - Minimal / (L) Step, In-panel, Side Spoiler - Scratch - Minimal / Roof - Dent - Minimal / (L) Front Fender, Molding - Scratch - Minimal / Front Bumper, Grille, Lamps - Scratch - Large / Bonnet, Headlight - Scratch - Minimal |

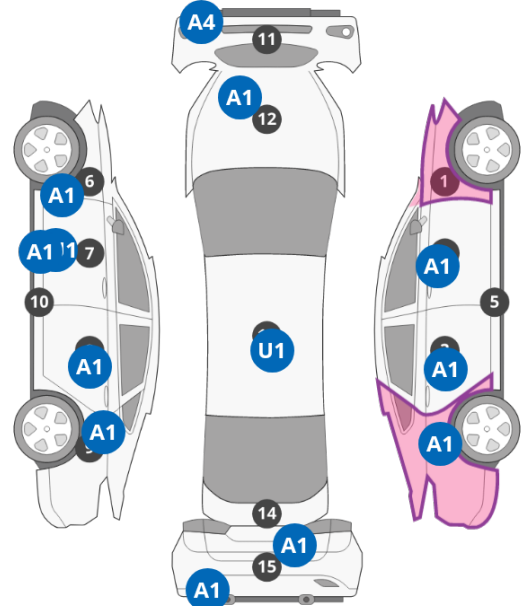
| Inspector Notes |
|---|
| With Lto plate, with spare tire and jack, with warranty booklet and tools, 3keys, scratches on headlights and taillights |
