## General Information

| Make | Toyota | Model | Wigo |
| YOM | 2025 | Odo Meter Reading | 10,004 |
| Registration No. | BAH3633 | Chassis No. | MHKAA1BC8SJ039419 |

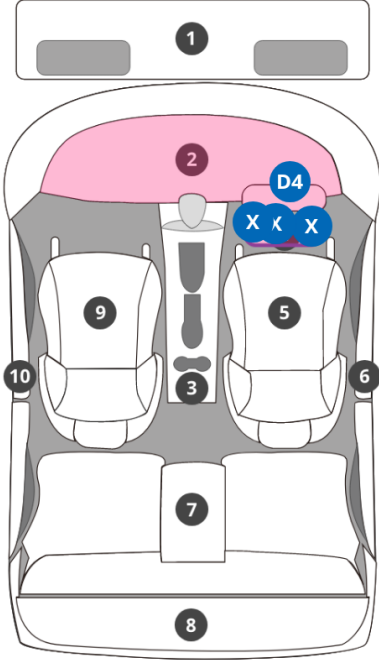
| Interior Evaluation : <span style="color: red;">C</span> | Exterior Evaluation : <span style="color: red;">C</span> |
| <b>Remarks</b><br>Glove Box - Loose, Deformed - Large / (R) Front Floor Mat - Missing - Yes / (L) Front Floor Mat - Missing - Yes / Mat Other - Missing - Yes | <b>Remarks</b><br>(L) Rear Door - Repair Traces - Yes / (R) Rear Door, Molding - Scratch - Small / (R) Step, In-panel, Side Spoiler - Scratch - Medium / Front Bumper, Grille, Lamps - Scratch - Large / Bonnet, Headlight - Scratch - Small / (L) Front Door, Molding - Scratch - Small / (L) Rear Door, Molding - Scratch - Medium / Rear Bumper, Lamps, Panels - Scratch - Minimal / Trunk Hood, Rear Gate - Scratch - Small / (R) Front Door, Molding - Scratch - Minimal / (R) Rear Fender, Molding - Scratch - Minimal |
