## General Information

| Make | Toyota | Model | Hilux Tamaraw |
| YOM | 2026 | Odo Meter Reading | 13,667 |
| Registration No. | NLC2855 | Chassis No. | PAHACACA3S6431346 |

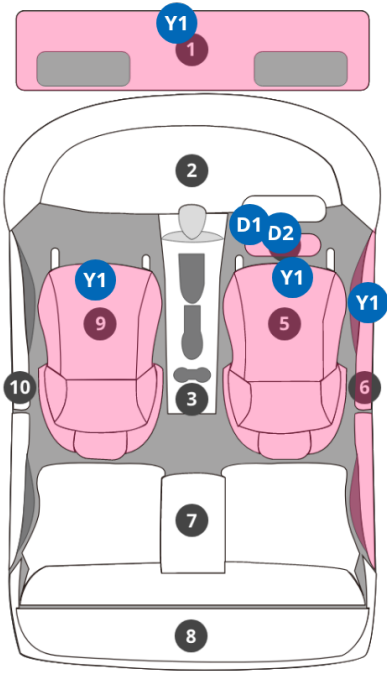
| Interior Evaluation : <span style="color: red; font-weight: bold;">A</span> | Exterior Evaluation : <span style="color: red; font-weight: bold;">D</span> |
|---|---|
| <b>Remarks</b><br>(R) Front Trim - Grime - Minimal / (R) Front Floor Mat - Worked - Small / Ceiling - Grime - Minimal / Carpet - Worked - Minimal / (L) Front Seat - Grime - Minimal / (R) Front Seat - Grime - Minimal | <b>Remarks</b><br>(R) Front Fender, Molding - Scratch - Medium / (R) Mirror - Scratch - Minimal / (R) Front Door, Molding - Scratch - Minimal / (R) Side Gate - Scratch & Dent - Large / Rear Gate - Scratch - Minimal / Rear Bumper, Lamps, Panels - Scratch - Minimal / (L) Side Gate - Scratch & Dent - Large / Roof - Scratch & Dent - Large / (L) Front Door, Molding - Scratch - Minimal / (L) Mirror - Scratch - Small / (L) Front Fender, Molding - Scratch - Minimal / Front Bumper, Grille, Lamps - Scratch - Small / Bonnet, Headlight - Scratch & Dent - Small / Cargo Bed Floor - Scratch - Medium |

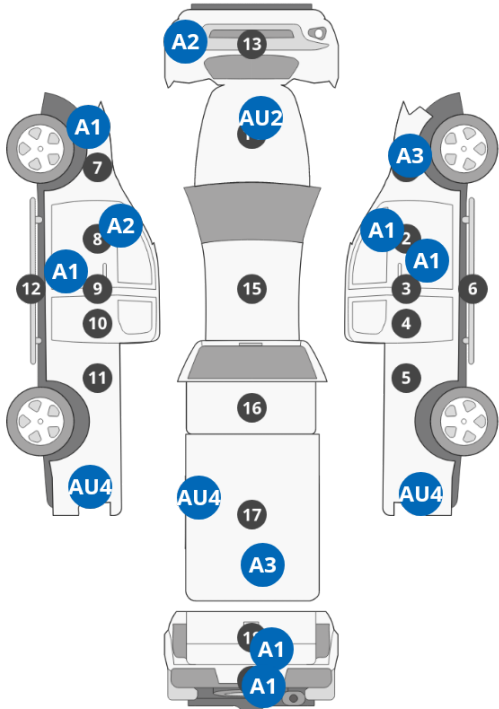
| Inspector Notes |
|---|
| With Lto plate, with spare tire and jack, with warranty booklet, 2keys, no tools, scratches on headlights |
