## General Information

| Make | Toyota | Model | Vios |

## Body / Panel Condition

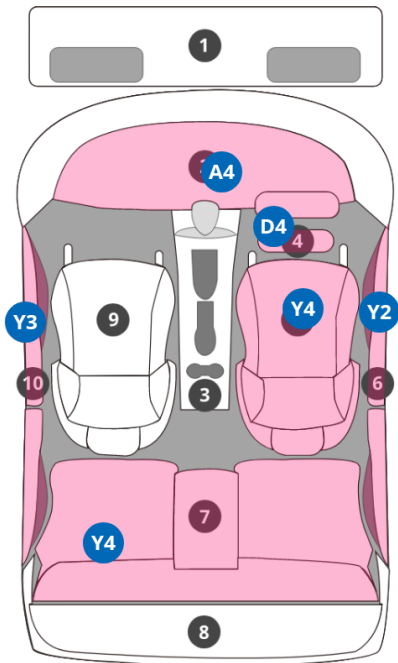
| Interior Evaluation : <span style="color: red;">C</span> | Exterior Evaluation : <span style="color: red;">E</span> |
|---|---|
| <b>Remarks</b><br>Dashboard - Worn, Scratch, Cut, Crack - Large / (R)<br>Front Seat - Grime - Large / (L) Front Trim - Grime - Medium / (R) Front Trim - Grime - Small / Rear Seat - Grime - Large / (L) Front Floor Mat - Worked - Large | <b>Remarks</b><br>Member (Bolted) - Dent - Yes / Bonnet, Headlight - Scratch & Dent - Medium / Front Bumper, Grille, Lamps - Scratch & Dent - Large / (L) Front Fender, Molding - Scratch & Dent - Medium / (L) Rear Door, Molding - Scratch & Dent - Small / (L) Rear Fender, Molding - Scratch - Small / Rear Bumper, Lamps, Panels - Repair mark - Yes / Trunk Hood, Rear Gate - Crack, Gap - Large / Rear Bumper, Lamps, Panels - Scratch - Medium / (R) Rear Door, Molding - Scratch & Dent - Medium / (R) Front Door, Molding - Scratch & Dent - Large / (R) Step, In-panel, Side Spoiler - Scratch & Dent - Large / (R) Front Fender, Molding - Crack, Gap - Large / Roof - Dent - Small |
