## General Information

| Make | Toyota | Model | Vios |

## Body / Panel Condition

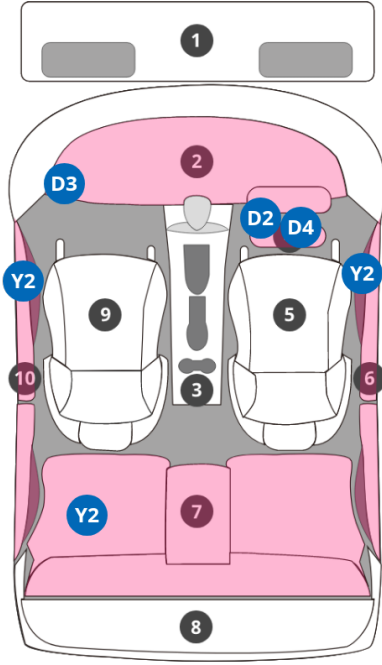
| Interior Evaluation : <span style="color: red;">C</span> | Exterior Evaluation : <span style="color: red;">C</span> |
|---|---|
| <b>Remarks</b><br>Dashboard - Loose, Deformed - Medium / (L) Front Trim - Grime - Small / (R) Front Trim - Grime - Small / (L) Front Floor Mat - Worked - Small / (R) Front Floor Mat - Worked - Large / Rear Seat - Grime - Small | <b>Remarks</b><br>Front Bumper, Grille, Lamps - Scratch & Dent - Medium / Rear Bumper, Lamps, Panels - Scratch & Dent - Medium / Trunk Hood, Rear Gate - Scratch & Dent - Medium / (R) Front Door, Molding - Scratch & Dent - Large / (R) Rear Door, Molding - Scratch - Medium / (L) Rear Fender, Molding - Scratch - Small / (L) Rear Door, Molding - Scratch - Small / (R) Rear Fender, Molding - Scratch - Small / (R) Front Fender, Molding - Scratch - Small |
