## General Information

| Make | Toyota | Model | Hilux Tamaraw |
| YOM | 2025 | Odo Meter Reading | 34,964 |
| Registration No. | NKT8604 | Chassis No. | PAHACACA1S6427358 |

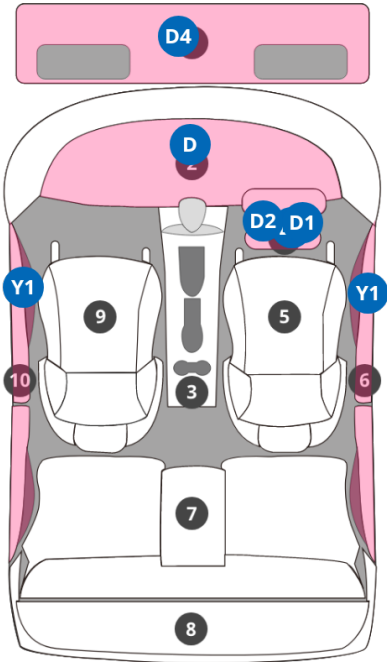
| Interior Evaluation : <span style="color: red;">C</span> | Exterior Evaluation : <span style="color: red;">E</span> |
| <b>Remarks</b><br>Ceiling - Loose, Deformed - Large / (R) Front Trim - Grime - Minimal / (R) Front Floor Mat - Worked - Small / (L) Front Floor Mat - Worked - Small / Carpet - Worked - Minimal / (L) Front Trim - Grime - Minimal / Dashboard - Traces of Adhesive Tape - Yes | <b>Remarks</b><br>(R) Front Fender, Molding - Scratch - Minimal / (R) Mirror - Scratch - Minimal / (R) Front Door, Molding - Scratch - Minimal / Roof - Scratch & Dent - Large / (R) Side Gate - Scratch & Dent - Medium / Cargo Bed Floor - Scratch & Dent - Large / Cab Back Panel - Scratch - Large / Rear Bumper, Lamps, Panels - Scratch & Dent - Minimal / Rear Gate - Scratch & Dent - Minimal / (L) Side Gate - Scratch - Large / (L) Front Door, Molding - Scratch - Minimal / (L) Mirror - Scratch - Minimal / (L) Front Fender, Molding - Scratch & Dent - Minimal / Front Bumper, Grille, Lamps - Scratch & Dent - Medium / Bonnet, Headlight - Scratch & Dent - Minimal / (R) Step, In-panel, Side Spoiler - Scratch - Minimal / (L) Step, In-panel, Side Spoiler - Scratch - Minimal |

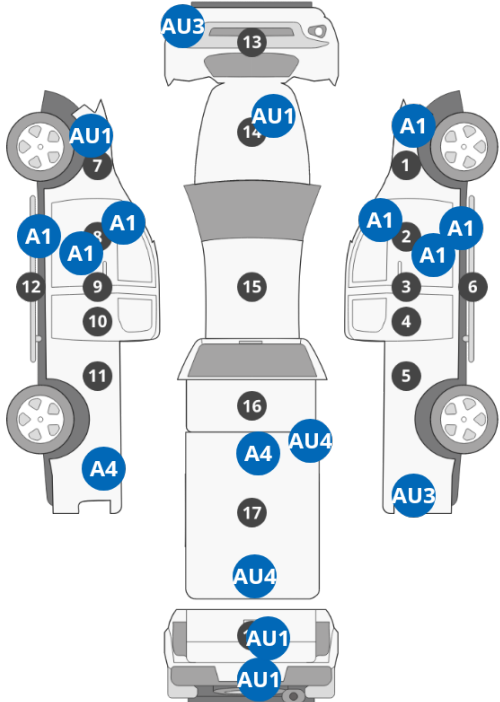
| Inspector Notes |
|---|
| With Lto plate, with spare tire, 1key, no warranty booklet and tools and Jack, scratches on headlights, fuel lid cover missing, battery weak |
