## General Information

| Make | Toyota | Model | Vios |
| YOM | 2025 | Odo Meter Reading | 34,573 |

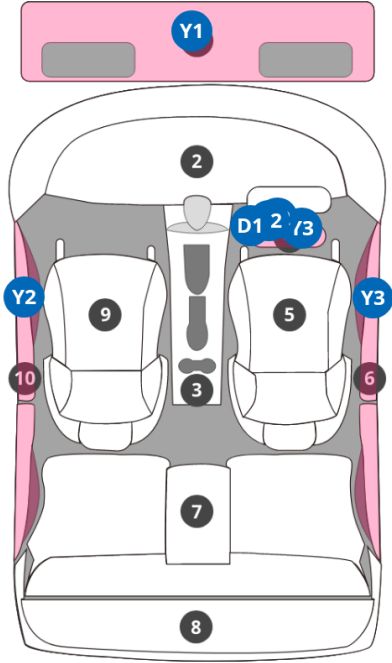
| Interior Evaluation : <b>B</b> | Exterior Evaluation : <b>C</b> |
| <p><b>Remarks</b></p> <p>Ceiling - Grime - Minimal / Mat Other - Grime - Medium / (R) Front Trim - Grime - Medium / (R) Front Floor Mat - Worked - Small / (L) Front Trim - Grime - Small / (L) Front Floor Mat - Cut, Crack - Small / Carpet - Worked - Minimal</p> | <p><b>Remarks</b></p> <p>(R) Front Fender, Molding - Dent - Small / (R) Front Door, Molding - Scratch - Minimal / (R) Step, In-panel, Side Spoiler - Scratch - Minimal / (R) Rear Door, Molding - Scratch - Minimal / (R) Rear Fender, Molding - Scratch - Minimal / Rear Bumper, Lamps, Panels - Scratch - Minimal / Trunk Hood, Rear Gate - Scratch - Minimal / (L) Rear Fender, Molding - Scratch - Minimal / (L) Step, In-panel, Side Spoiler - Scratch &amp; Dent - Large / (L) Rear Door, Molding - Scratch - Minimal / (L) Front Door, Molding - Scratch - Minimal / (L) Mirror - Scratch - Minimal / (L) Front Fender, Molding - Scratch - Minimal / Front Bumper, Grille, Lamps - Scratch &amp; Dent - Medium / Bonnet, Headlight - Scratch - Minimal / Roof - Scratch - Minimal</p> |

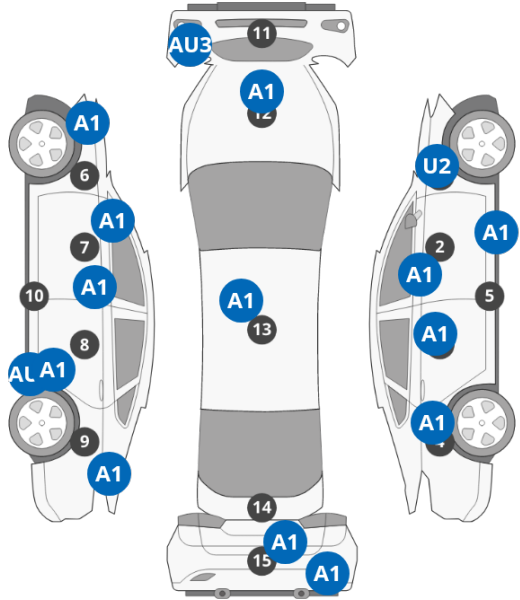
| Inspector Notes |
|---|
| With Lto plate, with spare tire and jack, with warranty booklet and tools, 2keys, scratches on headlights and taillights, worn rear tires, |
