## General Information

| Make | Toyota | Model | Hiace |

## Body / Panel Condition

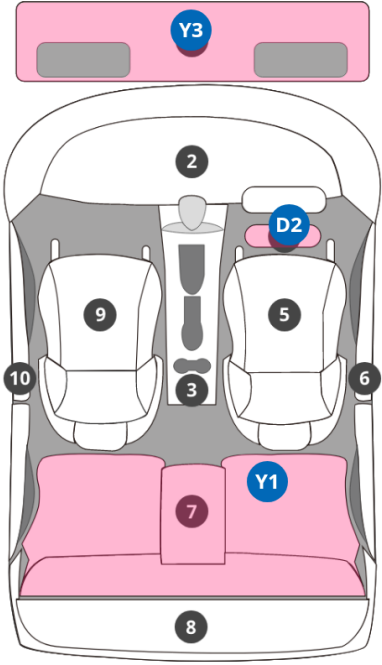
| Interior Evaluation : <b>B</b> | Exterior Evaluation : <b>C</b> |
|---|---|
| <b>Remarks</b><br>Ceiling - Grime - Medium / Rear Seat - Grime - Minimal / (L) Front Floor Mat - Worked - Small | <b>Remarks</b><br>(R) Front Fender, Molding - Scratch & Dent - Small / (R) Mirror - Scratch - Minimal / (R) Front Door, Molding - Scratch - Minimal / (R) Center Panel - Scratch & Dent - Minimal / (R) Rear Door, Molding - Scratch - Minimal / (R) Rear Fender, Molding - Scratch & Dent - Medium / Rear Bumper, Lamps, Panels - Scratch & Dent - Large / Trunk Hood, Rear Gate - Scratch & Dent - Minimal / (L) Rear Fender, Molding - Scratch & Dent - Large / (L) Front Door, Molding - Scratch - Minimal / (L) Front Fender, Molding - Scratch - Minimal / Front Bumper, Grille, Lamps - Scratch - Large / Bonnet, Headlight - Scratch - Minimal / (L) Step, In-panel, Side Spoiler - Scratch - Minimal |

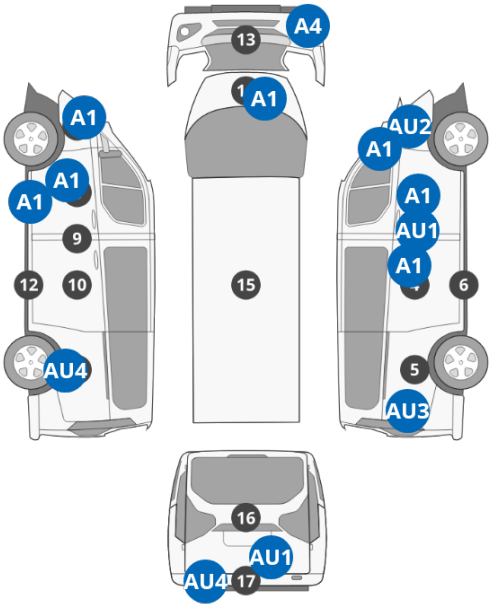
With Lto plate, with spare tire and jack, with warranty booklet, 2keys, scratches on headlights
