## General Information

| Make | Toyota | Model | Hilux Tamaraw |
| Registration No. | NJK6190 | Chassis No. | PAHACACA2S6429183 |

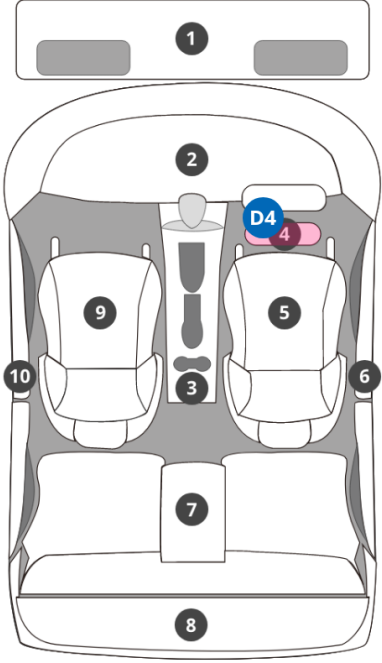
| Interior Evaluation : <b>C</b> | Exterior Evaluation : <b>E</b> |
| <b>Remarks</b><br>(L) Front Floor Mat - Worked - Large | <b>Remarks</b><br>Front Bumper, Grille, Lamps - Scratch & Dent - Large / (L) Step, In-panel, Side Spoiler - Scratch & Dent - Small / (L) Side Gate - Scratch & Dent - Large / (L) Guard Frame - Scratch & Dent - Large / Rear Bumper, Lamps, Panels - Scratch - Large / Cargo Bed Floor - Scratch & Dent - Large / Rear Gate - Scratch & Dent - Small / (R) Guard Frame - Scratch & Dent - Large / (R) Side Gate - Scratch & Dent - Large / (R) Front Door, Molding - Scratch & Dent - Medium / (R) Front Fender, Molding - Scratch & Dent - Small / Roof - Scratch - Large |

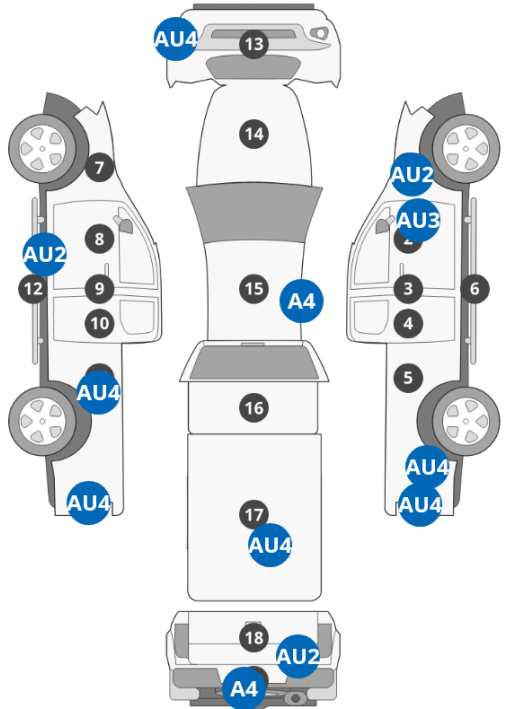
| Inspector Notes |
|---|
| no jack and tools/ light scratches around the exterior/ horn issue/ with LTO plate and warranty booklet/ with spare tire |
