## General Information

| Make | Toyota | Model | Vios |
| YOM | 2020 | Mileage | 102,449 |
| Registration No. | DBA6712 | Chassis No. | PA1B18F30L4117441 |

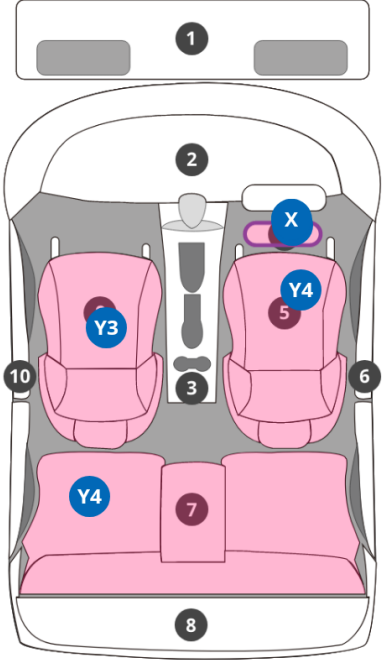
| Interior Evaluation : <span style="color: red;">C</span> | Exterior Evaluation : <span style="color: red;">E</span> |
| <b>Remarks</b><br>(R) Front Seat - Grime - Large / Rear Seat - Grime - Large / (L) Front Seat - Grime - Medium / (L) Front Floor Mat - Missing - Yes / (R) Front Floor Mat - Missing - Yes | <b>Remarks</b><br>(R) Step, In-panel, Side Spoiler - Scratch & Dent - Medium / (R) Rear Door, Molding - Scratch & Dent - Large / (R) Front Door, Molding - Scratch & Dent - Large / (R) Front Fender, Molding - Scratch - Large / Bonnet, Headlight - Dent - Small / Front Bumper, Grille, Lamps - Scratch - Large / (L) Front Fender, Molding - Scratch & Dent - Medium / (L) Rear Fender, Molding - Scratch - Medium / (L) Front Door, Molding - Scratch - Minimal / Rear Bumper, Lamps, Panels - Scratch - Large / (R) Rear Fender, Molding - Scratch - Medium / Trunk Hood, Rear Gate - Dent - Small / (L) Rear Door, Molding - Scratch - Minimal |

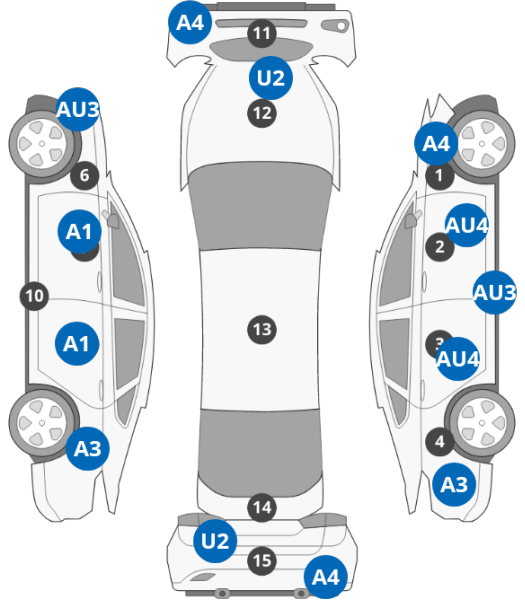
| Inspector Notes |
|---|
| with LTO plate/with spare tire/with jack/with warranty booklet/without tools/right side mirror broken/reverse camera not function |
