## General Information

| Make | Toyota | Model | Vios |
| YOM | 2021 | Odo Meter Reading | 43,679 |
| Registration No. | FAF4280 | Chassis No. | PA1B18F33M4134610 |

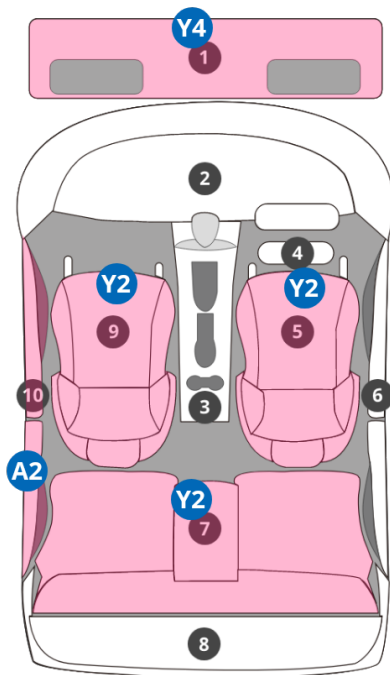
| Interior Evaluation : <b>C</b> | Exterior Evaluation : <b>D</b> |
| <p><b>Remarks</b><br/>Ceiling - Grime - Large / (R) Front Seat - Grime - Small / Rear Seat - Grime - Small / (L) Rear Trim - Cut, Crack - Small / (L) Front Seat - Grime - Small</p> | <p><b>Remarks</b><br/>(R) Front Fender, Molding - Scratch - Small / (R) Front Door, Molding - Dent - Small / (R) Rear Door, Molding - Scratch &amp; Dent - Medium / Rear Bumper, Lamps, Panels - Scratch - Large / (L) Rear Fender, Molding - Dent - Minimal / (L) Rear Door, Molding - Scratch - Large / (L) Front Door, Molding - Scratch - Large / (L) Mirror - Scratch, Peeled - Minimal / Bonnet, Headlight - Dent - Small / Front Bumper, Grille, Lamps - Scratch - Medium / (L) Front Fender, Molding - Crack, Gap - Small</p> |
