## General Information

| Make | Mitsubishi | Model | Mirage |

## Overall Evaluation :

**A**

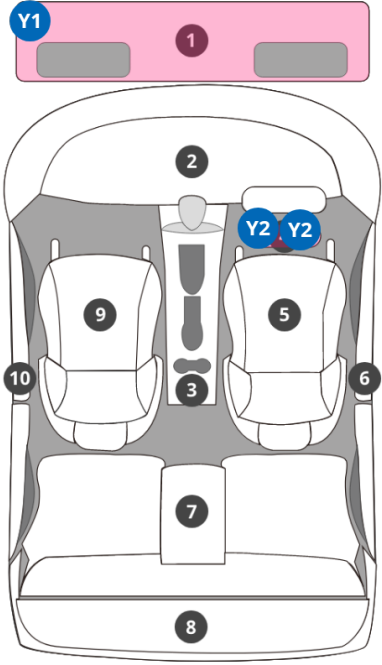
| Interior Evaluation : <span style="color: red; font-weight: bold;">A</span> | Exterior Evaluation : <span style="color: red; font-weight: bold;">C</span> |
| <b>Remarks</b><br>Ceiling - Grime - Minimal / Mat Other - Grime - Small / (L) Front Floor Mat - Grime - Small | <b>Remarks</b><br>(R) Front Fender, Molding - Scratch - Minimal / (R) Front Door, Molding - Scratch - Small / (R) Rear Door, Molding - Scratch - Minimal / (R) Rear Fender, Molding - Scratch - Small / Rear Bumper, Lamps, Panels - Scratch - Medium / Trunk Hood, Rear Gate - Scratch - Small / (L) Rear Fender, Molding - Scratch - Minimal / (L) Rear Door, Molding - Scratch - Small / (L) Front Door, Molding - Scratch - Small / (L) Front Fender, Molding - Scratch - Small / Front Bumper, Grille, Lamps - Scratch - Minimal / Bonnet, Headlight - Scratch - Minimal / Roof - Scratch - Minimal |

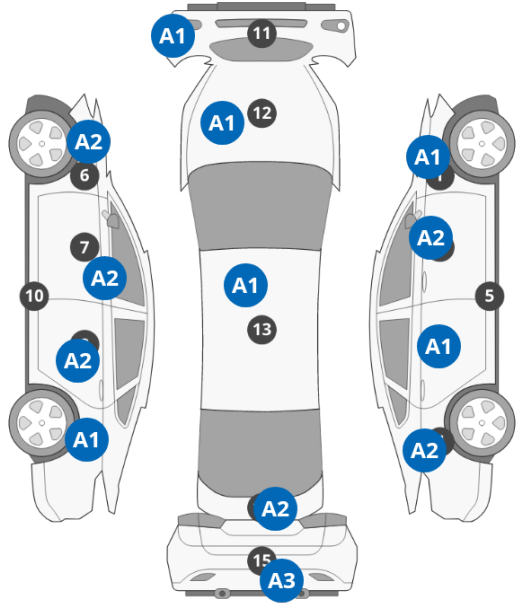
| Inspector Notes |
|---|
| with warranty booklet, jack and tools, with spare tire, with LTO plate, minor scratches on taillight |
