BLUE-T VEHICLE GRADING SYSTEM

Grading Report

Make	Mitsubishi	**Model**	Mirage
YOM	2026	**Odo Meter Reading**	10,702
Registration No.	NJK7017	**Chassis No.**	PAEA13RXTSA002817
CC	1.2	**Transmission**	CVT
Fuel Type	Gas	**Type of Body**	Sedan
Colour	Gray

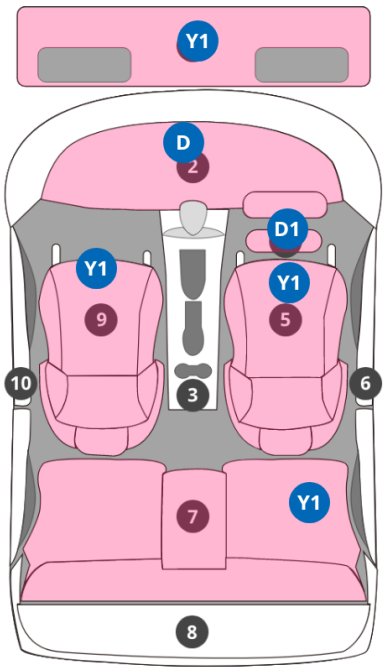
Interior Evaluation : A	Exterior Evaluation : B

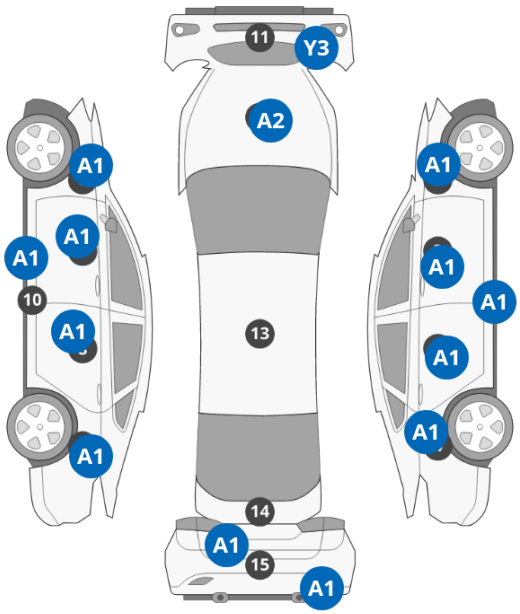
A : Scratch AU : Scratch & Dent B : Modified C : Corrosion G : Stone chip P : Faded S : Rust SC : Rust & Corrosion U : Dent X : Defective Y : Crack, Gap
Remarks Ceiling - Grime - Minimal / Rear Seat - Grime - Minimal / Dashboard - Traces of Adhesive Tape - Yes / Carpet - Worked - Minimal / (R) Front Seat - Grime - Minimal / (L) Front Seat - Grime - Minimal	**Remarks** (R) Front Fender - Repair Traces - Yes / (R) Rear Fender - Repair Traces - Yes / (R) Rear Door - Repair Traces - Yes / (R) Front Fender, Molding - Scratch - Minimal / (R) Front Door, Molding - Scratch - Minimal / (R) Step, In-panel, Side Spoiler - Scratch - Minimal / (R) Rear Door, Molding - Scratch - Minimal / (R) Rear Fender, Molding - Scratch - Minimal / Rear Bumper, Lamps, Panels - Scratch - Minimal / Trunk Hood, Rear Gate - Scratch - Minimal / (L) Rear Fender, Molding - Scratch - Minimal / (L) Rear Door, Molding - Scratch - Minimal / (L) Front Door, Molding - Scratch - Minimal / (L) Step, In-panel, Side Spoiler - Scratch - Minimal / (L) Front Fender, Molding - Scratch - Minimal / Front Bumper, Grille, Lamps - Crack, Gap - Medium / Bonnet, Headlight - Scratch - Small

Inspector Notes
With Lto plate, with spare tire and jack, 2keys, no warranty booklet and tools, scratches on headlights
