BLUE-T
VEHICLE GRADING SYSTEM

Grading Report

Make	Toyota	**Model**	Hilux Tamaraw
YOM	2026	**Odo Meter Reading**	9,577
Registration No.	CDC5288	**Chassis No.**	PAHACACA7T6435898
CC	2.4	**Transmission**	M/T
Fuel Type	Diesel	**Type of Body**	Utility Passenger
Colour	White

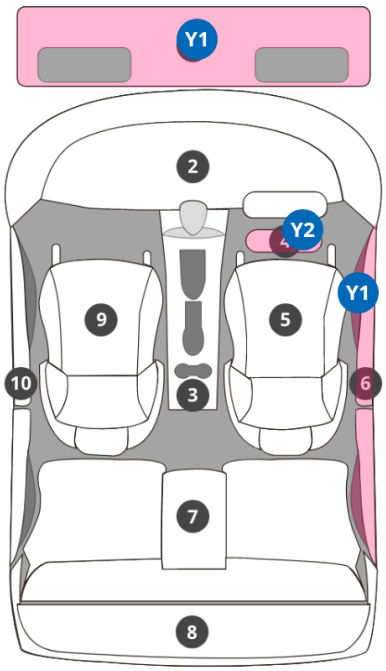
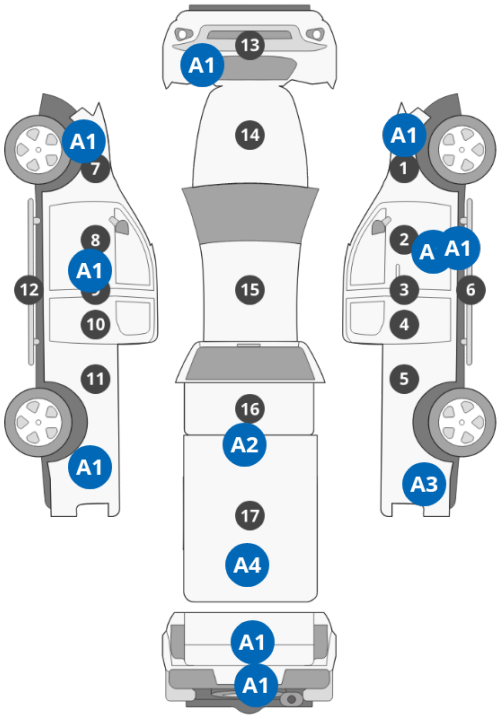
Interior Evaluation : A	Exterior Evaluation : C

a : Cut, Fray d : Loose, Deformed k : Animal Hair s : Smell t : Cigarette Burns x : Defective y : Stain	A : Scratch AU : Scratch & Dent B : Modified C : Corrosion G : Stone chip P : Faded S : Rust SC : Rust & Corrosion U : Dent X : Defective Y : Crack, Gap
Remarks Ceiling - Grime - Minimal / (R) Front Floor Mat - Grime - Small / (R) Front Trim - Grime - Minimal	**Remarks** (R) Front Fender, Molding - Scratch - Minimal / (R) Front Door, Molding - Scratch - Minimal / (R) Step, In-panel, Side Spoiler - Scratch - Minimal / (R) Side Gate - Scratch - Medium / Rear Bumper, Lamps, Panels - Scratch - Minimal / Cargo Bed Floor - Scratch - Large / Cab Back Panel - Scratch - Small / Rear Gate - Scratch - Minimal / (L) Side Gate - Scratch - Minimal / (L) Front Door, Molding - Scratch - Minimal / (L) Front Fender, Molding - Scratch - Minimal / Front Bumper, Grille, Lamps - Scratch - Minimal
