BLUE-T
VEHICLE GRADING SYSTEM

Grading Report

Make	Toyota	**Model**	Lite Ace
YOM	2023	**Odo Meter Reading**	12,388
Registration No.	NHJ6461	**Chassis No.**	MHKU3FE10PK003783
CC	1.5	**Transmission**	M/T
Fuel Type	Gas	**Type of Body**	Pickup
Colour	White

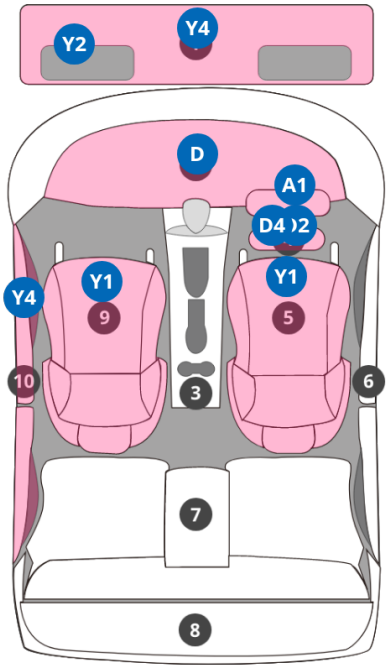
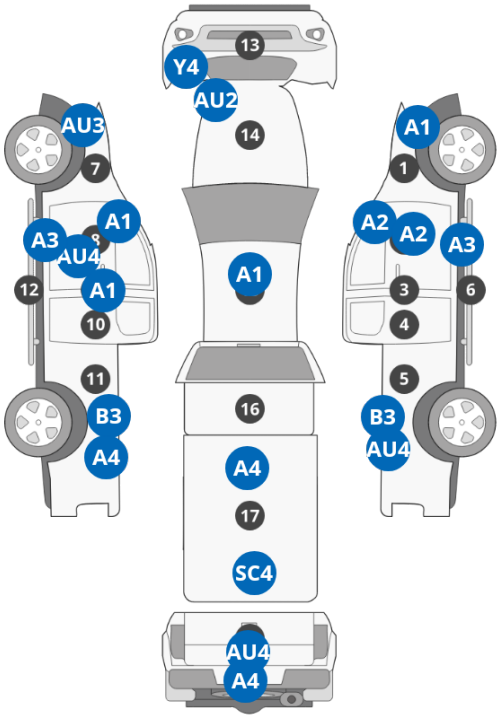
Interior Evaluation : C	Exterior Evaluation : E

a : Cut, Fray d : Loose, Deformed k : Animal Hair s : Smell t : Cigarette Burns x : Defective y : Stain	A : Scratch AU : Scratch & Dent B : Modified C : Corrosion G : Stone chip P : Faded S : Rust SC : Rust & Corrosion U : Dent X : Defective Y : Crack, Gap
Remarks Ceiling - Grime - Large / Glove Box - Worn, Scratch, Cut, Crack - Minimal / Dashboard - Traces of Adhesive Tape - Yes / (L) Front Seat - Grime - Minimal / (R) Front Seat - Grime - Minimal / (L) Front Floor Mat - Worked - Small / (L) Front Trim - Grime - Large / Sunvisor, Sunglass Holder - Grime - Small / Carpet - Worked - Large / Overall Interior - Worn as per age - Yes	**Remarks** (L) Front Fender - Repair Traces - Yes / (R) Front Fender, Molding - Scratch - Minimal / (R) Mirror - Scratch - Small / (R) Front Door, Molding - Scratch - Small / (R) Step, In-panel, Side Spoiler - Scratch - Medium / (R) Side Gate - Modified - Medium / (R) Side Gate - Scratch & Dent - Large / Rear Bumper, Lamps, Panels - Scratch - Large / Rear Gate - Scratch & Dent - Large / Cargo Bed Floor - Rust, Corrosion - Large / Cab Back Panel - Scratch - Large / (L) Side Gate - Modified - Medium / (L) Side Gate - Scratch - Large / (L) Center Panel - Scratch - Minimal / (L) Front Door, Molding - Scratch & Dent - Large / (L) Front Fender, Molding - Scratch & Dent - Medium / Front Bumper, Grille, Lamps - Crack, Gap - Large / Bonnet, Headlight - Scratch & Dent - Small / Roof - Scratch - Minimal / (L) Step, In-panel, Side Spoiler - Scratch - Medium / (L) Mirror - Scratch - Minimal

With Lto plate, with spare tire and jack, 1key, no warranty booklet and tools, Crack headlight and taillight
