BLUE-T
VEHICLE GRADING SYSTEM

Grading Report

Make	Toyota	**Model**	Vios
YOM	2025	**Odo Meter Reading**	21,461
Registration No.	NOA7352	**Chassis No.**	PA1B18D35S4290323
CC	1.3	**Transmission**	CVT
Fuel Type	Gas	**Type of Body**	Sedan
Colour	Blackish Red Mica

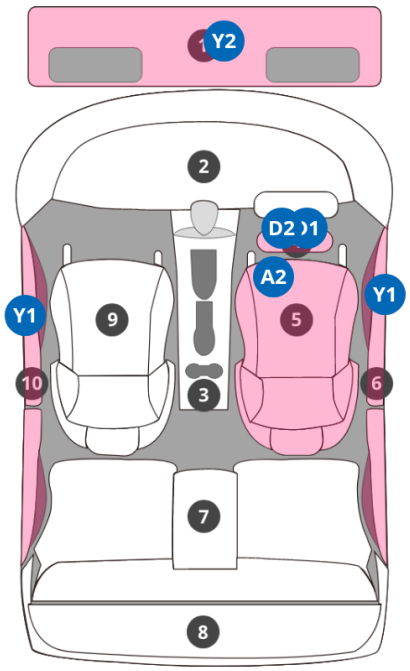
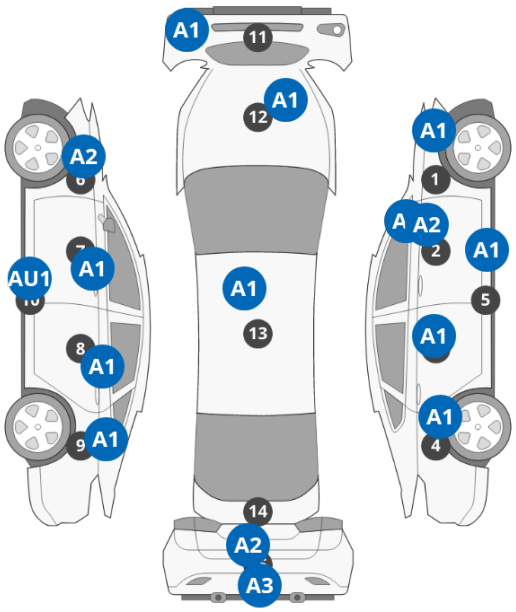
Interior Evaluation : A	Exterior Evaluation : B

a : Cut, Fray d : Loose, Deformed k : Animal Hair s : Smell t : Cigarette Burns x : Defective y : Stain	A : Scratch AU : Scratch & Dent B : Modified C : Corrosion G : Stone chip P : Faded S : Rust SC : Rust & Corrosion U : Dent X : Defective Y : Crack, Gap
Remarks Ceiling - Grime - Small / (R) Front Trim - Grime - Minimal / (R) Front Seat - Cut, Crack - Small / (L) Front Trim - Grime - Minimal / Carpet - Worked - Minimal / (L) Front Floor Mat - Worked - Small	**Remarks** Trunk Hood, Rear Gate - Repair Traces - Yes / (R) Front Fender, Molding - Scratch - Minimal / (R) Mirror - Scratch - Minimal / (R) Front Door, Molding - Scratch - Small / (R) Step, In-panel, Side Spoiler - Scratch - Minimal / (R) Rear Door, Molding - Scratch - Minimal / (R) Rear Fender, Molding - Scratch - Minimal / Rear Bumper, Lamps, Panels - Scratch - Medium / Trunk Hood, Rear Gate - Scratch - Small / (L) Rear Fender, Molding - Scratch - Minimal / (L) Rear Door, Molding - Scratch - Minimal / (L) Step, In-panel, Side Spoiler - Scratch & Dent - Minimal / (L) Front Door, Molding - Scratch - Minimal / Roof - Scratch - Minimal / (L) Front Fender, Molding - Scratch - Small / Front Bumper, Grille, Lamps - Scratch - Minimal / Bonnet, Headlight - Scratch - Minimal
