BLUE-T VEHICLE GRADING SYSTEM

Grading Report

Make	Toyota	**Model**	Hilux Tamaraw
YOM	2026	**Odo Meter Reading**	12,709
Registration No.	GBL5826	**Chassis No.**	PAHACACA4S5433008
CC	2.4	**Transmission**	M/T
Fuel Type	Diesel	**Type of Body**	Utility Passenger
Colour	White

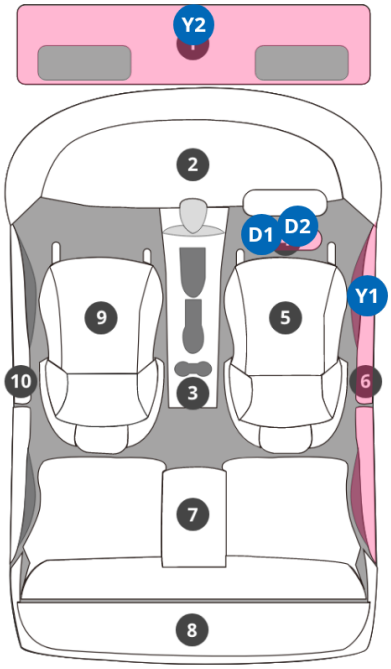
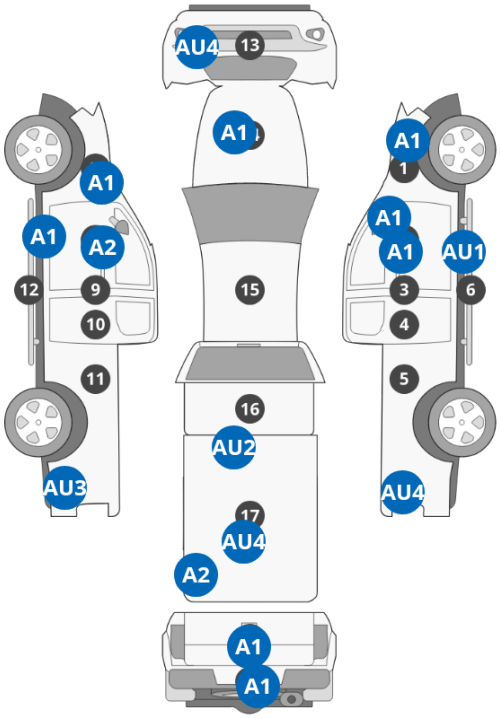
Interior Evaluation : A	Exterior Evaluation : D

a : Cut, Fray d : Loose, Deformed k : Animal Hair s : Smell t : Cigarette Burns x : Defective y : Stain	A : Scratch AU : Scratch & Dent B : Modified C : Corrosion G : Stone chip P : Faded S : Rust SC : Rust & Corrosion U : Dent X : Defective Y : Crack, Gap
Remarks (L) Front Floor Mat - Worked - Small / Carpet - Worked - Minimal / Ceiling - Grime - Small / (R) Front Trim - Grime - Minimal	**Remarks** (R) Front Fender, Molding - Scratch - Minimal / (R) Mirror - Scratch - Minimal / (R) Front Door, Molding - Scratch - Minimal / (R) Step, In-panel, Side Spoiler - Scratch & Dent - Minimal / (R) Side Gate - Scratch & Dent - Large / Rear Bumper, Lamps, Panels - Scratch - Minimal / Cargo Bed Floor - Scratch & Dent - Large / Cab Back Panel - Scratch & Dent - Small / Rear Gate - Scratch - Minimal / (L) Side Gate - Scratch & Dent - Medium / Roof - Scratch - Small / (L) Front Door, Molding - Scratch - Small / (L) Front Fender, Molding - Scratch - Minimal / Front Bumper, Grille, Lamps - Scratch & Dent - Large / Bonnet, Headlight - Scratch - Minimal / (L) Step, In-panel, Side Spoiler - Scratch - Minimal

With Lto plate, with spare tire, 2keys, no warranty booklet and tools and Jack, scratches on headlights,
