BLUE-T VEHICLE GRADING SYSTEM

Grading Report

Make	Isuzu	**Model**	NLR77
YOM	2021	**Odo Meter Reading**	154,271
Registration No.	NGA9469	**Chassis No.**	PABNLR77HL2000254
CC	3.0	**Transmission**	M/T
Fuel Type	Diesel	**Type of Body**	Aluminum Van
Colour	White

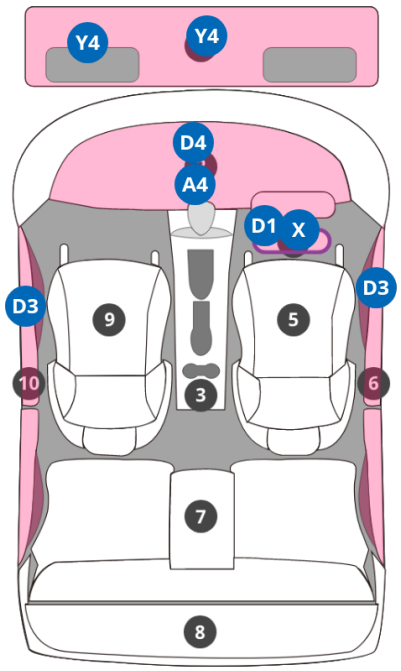
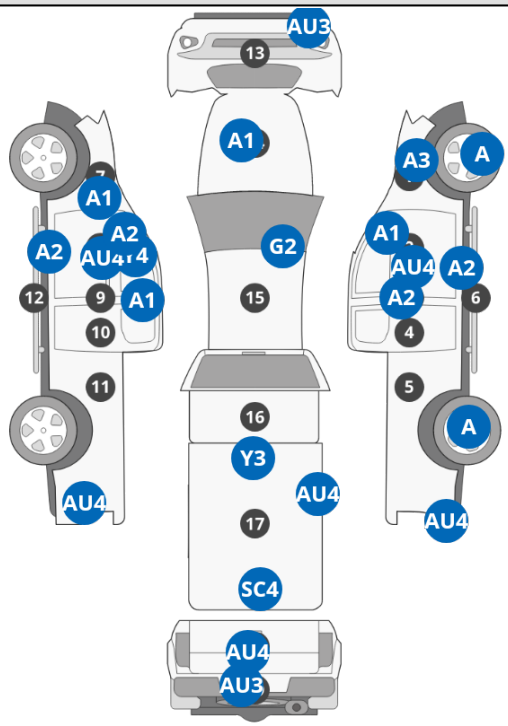
Interior Evaluation : D	Exterior Evaluation : E

a : Cut, Fray d : Loose, Deformed k : Animal Hair s : Smell t : Cigarette Burns x : Defective y : Stain	A : Scratch AU : Scratch & Dent B : Modified C : Corrosion G : Stone chip P : Faded S : Rust SC : Rust & Corrosion U : Dent X : Defective Y : Crack, Gap
Remarks Ceiling - Grime - Large / Sunvisor, Sunglass Holder - Grime - Large / Steering Wheel - Worn, Peel, Crack - Large / (L) Front Trim - Loose, Deformed - Medium / (L) Front Floor Mat - Missing - Yes / Carpet - Worked - Minimal / Dashboard - Loose, Deformed - Large / (R) Front Trim - Loose, Deformed - Medium	**Remarks** (R) Front Fender, Molding - Scratch - Medium / (R) Mirror - Scratch - Minimal / (R) Front Door, Molding - Scratch & Dent - Large / (R) Center Panel - Scratch - Small / (R) Step, In-panel, Side Spoiler - Scratch - Small / (R) Side Gate - Scratch & Dent - Large / Rear Bumper, Lamps, Panels - Scratch & Dent - Medium / Rear Gate - Scratch & Dent - Large / Roof - Scratch & Dent - Large / Cargo Bed Floor - Rust, Corrosion - Large / Cab Back Panel - Crack, Gap - Medium / (L) Side Gate - Scratch & Dent - Large / (L) Center Panel - Scratch - Minimal / (L) Side Window - Damaged - Large / (L) Front Door, Molding - Scratch & Dent - Large / (R) Front Tyre - Crack, Cut - Yes / (R) Rear Tyre - Crack, Cut - Yes / (L) Front Fender, Molding - Scratch - Minimal / Front Windshield - Scratch, Stone chip - Small / Front Bumper, Grille, Lamps - Scratch & Dent - Medium / Front Panel - Scratch - Minimal / (L) Step, In-panel, Side Spoiler - Scratch - Small / (L) Mirror - Scratch - Small

Frame Evaluation : A	**Functional Evaluation : D**
Remarks Defects not found	**Remarks** Power Window (each) - Stuck, Gap - Yes / Air Conditioner - Function - Weak / Audio, Radio - Issue - Yes / Reverse Camera - N/A - Yes / Spare Key - Issue - Unexist

With Lto plate, 1key, no warranty booklet and tools, no spare tire and jack, rear gate issue,Worn tires, left window issue,aircon issue,
