Grading Report

Make	Toyota	**Model**	Vios
YOM	2024	**Mileage**	9,693
Registration No.	NKC6810	**Chassis No.**	PA1B18F34R4254004
CC	1.3	**Transmission**	CVT
Fuel Type	Gas	**Type of Body**	Sedan
Colour	Red

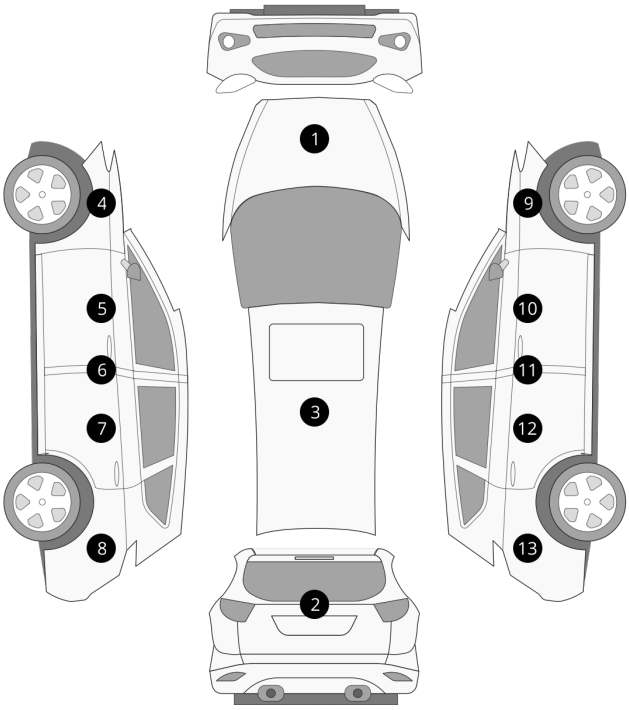
Body / Panel Condition

#	Area	Thickness(um)			
		Average	Value1	Value2	Value3/4
1	Bonnet	**134.0**	126	138	138
2	Boot Lid	**140.3**	132	144	145
3	Roof	**130.5**	135	137	130/120
4	Left Front Fender	**116.6**	117	112	121
5	Left Front Door	**122.6**	126	124	118
6	Center Panel Left				
7	Left Rear Door	**121.6**	127	126	112
8	Left Back Panel	**133.3**	139	132	129
9	Right Front Fender	**124.3**	129	123	121
10	Right Front Door	**124.3**	130	122	121
11	Center Panel Right				
12	Right Rear Door	**131.3**	118	127	149
13	Right Back Panel	**133.0**	132	135	132

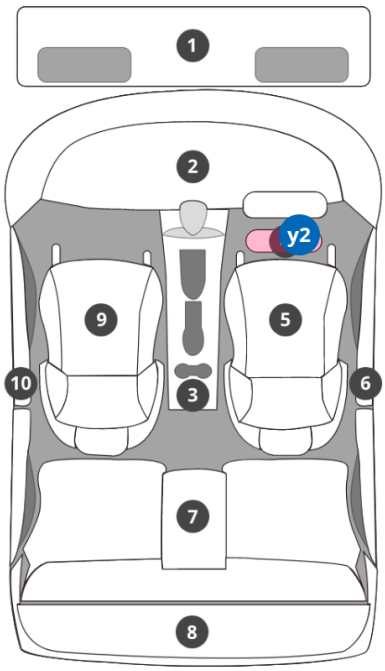
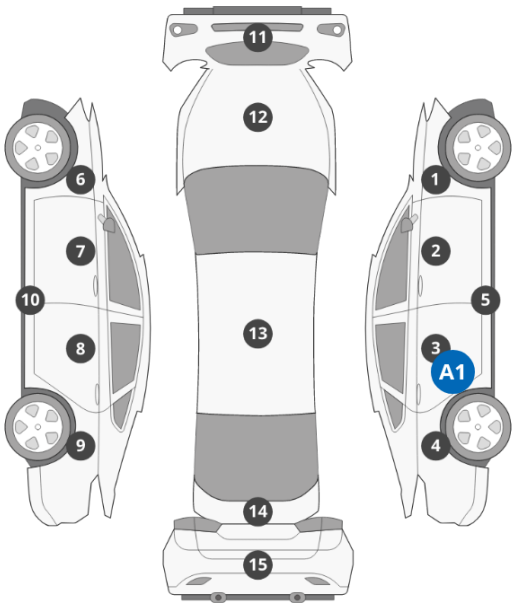
Interior Evaluation : A	Exterior Evaluation : A

Inspector Notes
repainted bumper/incomplete tools/jack/with spare tire/no warranty booklets
