BLUE-T VEHICLE GRADING SYSTEM

Grading Report

Make	Toyota	**Model**	Vios
YOM	2023	**Mileage**	6,436
Registration No.	NHI8760	**Chassis No.**	PA1B18F32P4213559
CC	1.3	**Transmission**	M/T
Fuel Type	Gas	**Type of Body**	Sedan
Colour	Green

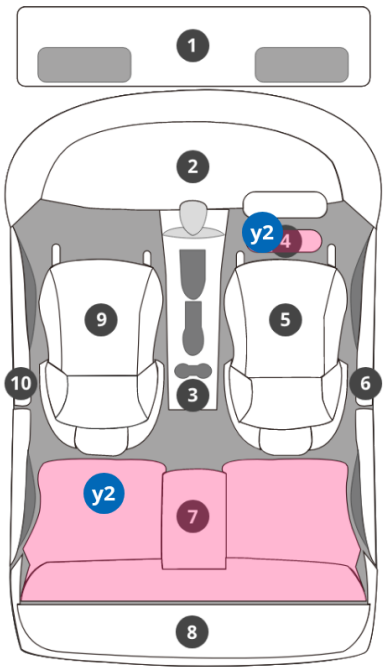
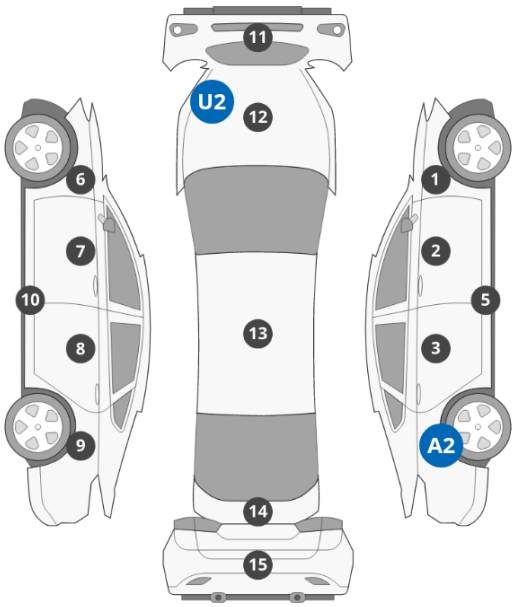
Interior Evaluation : A	Exterior Evaluation : A

a : Cut, Fray d : Loose, Deformed k : Animal Hair s : Smell t : Cigarette Burns x : Defective y : Stain	A : Scratch AU : Scratch & Dent B : Modified C : Corrosion G : Stone chip P : Faded S : Rust SC : Rust & Corrosion U : Dent X : Defective Y : Crack, Gap
Remarks (L) Front Floor Mat - Grime - Small / Rear Seat - Grime - Small	**Remarks** Bonnet, Headlight - Dent - Small / (R) Rear Fender, Molding - Scratch - Small
Frame Evaluation : A	**Functional Evaluation : C**
Remarks Defects not found	**Remarks** Power Steering - Issue - Yes / Battery - Weak - Yes / Reverse Camera - N/A - Yes / Spare Key - Issue - Unexist

Inspector Notes
dirtmarks at the trunk floor. hairline scratches around the exterior. no user manual. With warranty booklet and tools.
