Grading Report

Make	Toyota	**Model**	Vios
YOM	2024	**Mileage**	49,515
Registration No.	DBJ7185	**Chassis No.**	PA1B18F31P4226643
CC	1.3	**Transmission**	M/T
Fuel Type	Gas	**Type of Body**	Sedan
Colour	Blue

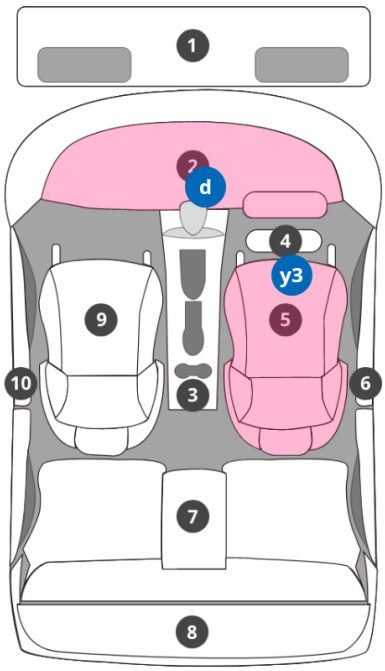
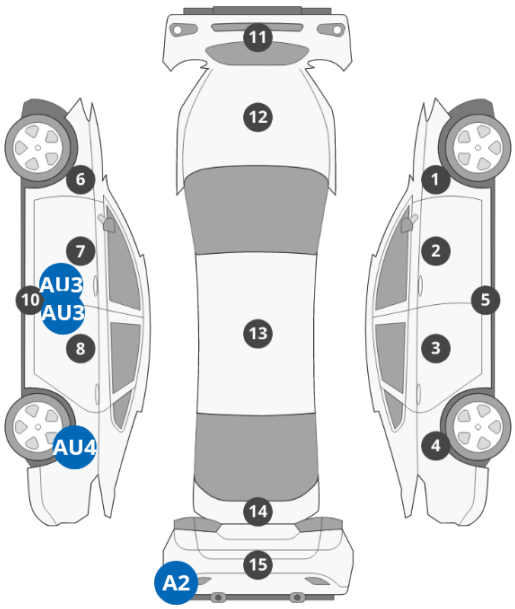
Interior Evaluation : B	Exterior Evaluation : C

Inspector Notes
with spare tire/jack/warranty booklets/incomplete tools/no reverse camera
