BLUE-T VEHICLE GRADING SYSTEM

Grading Report

Make	Toyota	**Model**	Vios
YOM	2023	**Mileage**	5,018
Registration No.	DAS8312	**Chassis No.**	PA1B18F35N419115
CC	1.3	**Transmission**	M/T
Fuel Type	Gas	**Type of Body**	Sedan
Colour	Blue

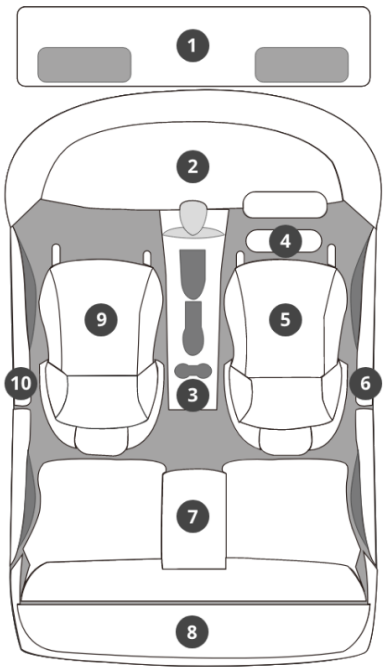
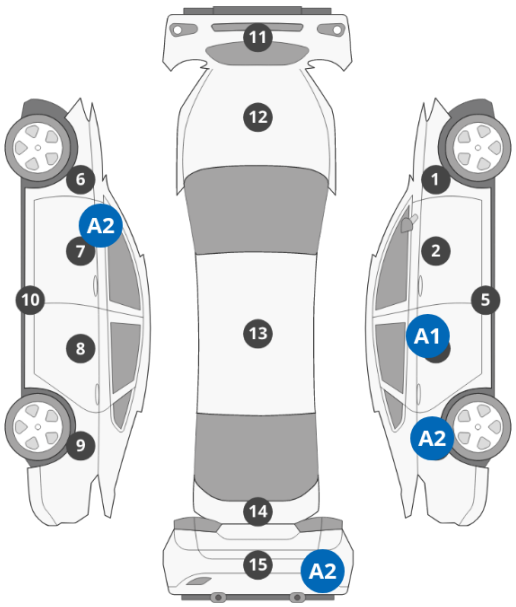
Interior Evaluation : A	Exterior Evaluation : A

a : Cut, Fray d : Loose, Deformed k : Animal Hair s : Smell t : Cigarette Burns x : Defective y : Stain	A : Scratch AU : Scratch & Dent B : Modified C : Corrosion G : Stone chip P : Faded S : Rust SC : Rust & Corrosion U : Dent X : Defective Y : Crack, Gap
Remarks Defects not found	**Remarks** Bonnet - Repair Traces - Yes / (L) Mirror - Scratch - Small / (R) Rear Door, Molding - Scratch - Minimal / (R) Rear Fender, Molding - Scratch - Small / Rear Bumper, Lamps, Panels - Scratch - Small
Frame Evaluation : A	**Functional Evaluation : A**
Remarks Defects not found	**Remarks** Reverse Camera - N/A - Yes / Spare Key - Issue - Unexist

Inspector Notes
Bonnet/Hood had been replaced. adhesive mark at the left side mirror. swirlmarks and hairline scratches around the exterior.With warranty booklet and user manual. no tools.
