BLUE-T VEHICLE GRADING SYSTEM

Grading Report

Make	Toyota	**Model**	Vios
YOM	2024	**Mileage**	6,287
Registration No.	CCA7581	**Chassis No.**	PA1B18F30R4256803
CC	1.3	**Transmission**	CVT
Fuel Type	Gas	**Type of Body**	Sedan
Colour	Black

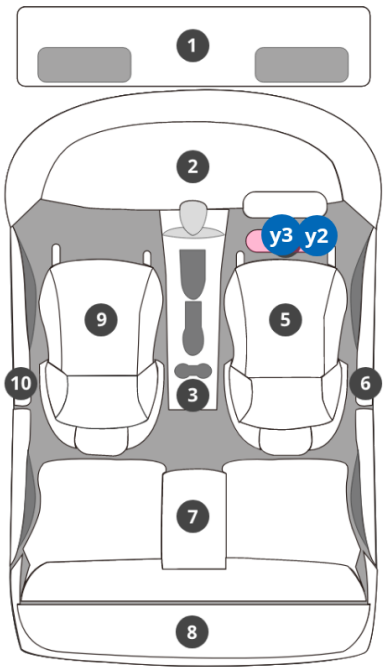
**A** : Scratch **AU** : Scratch & Dent **B** : Modified **C** : Corrosion **G** : Stone chip **P** : Faded **S** : Rust **SC** : Rust & Corrosion **U** : Dent **X** : Defective **Y** : Crack, Gap
Remarks (L) Front Floor Mat - Grime - Medium / (R) Front Floor Mat - Grime - Small	**Remarks** (R) Step, In-panel, Side Spoiler - Scratch & Dent - Small / (R) Rear Door, Molding - Scratch & Dent - Medium / (R) Front Door, Molding - Scratch & Dent - Small
Frame Evaluation : A	**Functional Evaluation : A**
Remarks Defects not found	**Remarks** Spare Key - Issue - Unexist

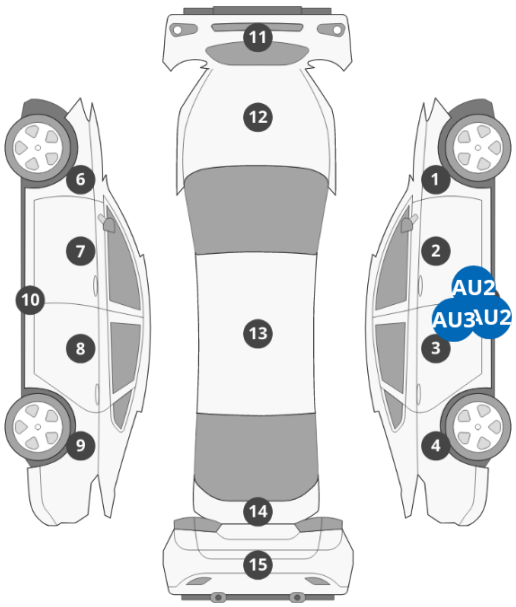
Inspector Notes
swirlmarks and hairline scratches around the exterior. with warranty booklet, user manual and tools.
