BLUE-T VEHICLE GRADING SYSTEM

Grading Report

Make	Toyota	**Model**	Vios
YOM	2023	**Mileage**	100,097
Registration No.	DBH7852	**Chassis No.**	PA1B18F31P4209938
CC	1.3	**Transmission**	CVT
Fuel Type	Gas	**Type of Body**	Sedan
Colour	BLACKISH RED MICA

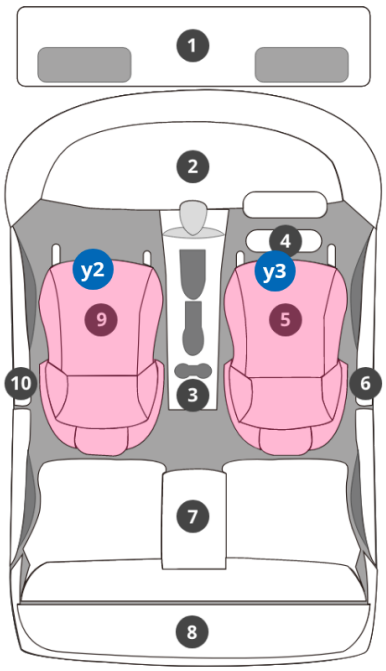
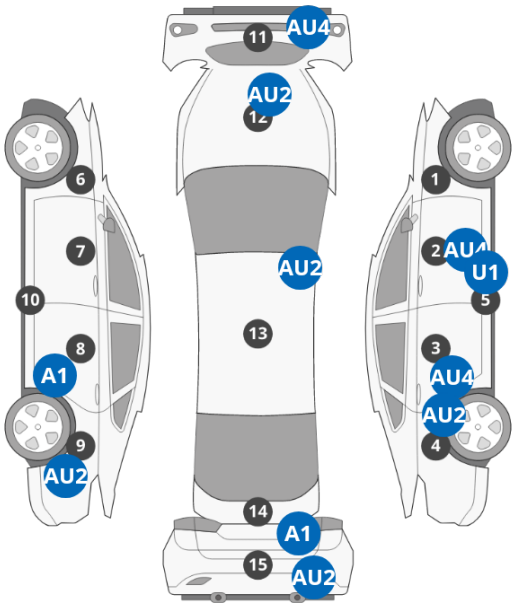
Interior Evaluation : B	Exterior Evaluation : C

a : Cut, Fray d : Loose, Deformed k : Animal Hair s : Smell t : Cigarette Burns x : Defective y : Stain	A : Scratch AU : Scratch & Dent B : Modified C : Corrosion G : Stone chip P : Faded S : Rust SC : Rust & Corrosion U : Dent X : Defective Y : Crack, Gap
Remarks (L) Front Seat - Grime - Small / (R) Front Seat - Grime - Medium	**Remarks** (R) Rear Door, Molding - Scratch & Dent - Large / (R) Front Door, Molding - Scratch & Dent - Large / (R) Rear Fender, Molding - Scratch & Dent - Small / Rear Bumper, Lamps, Panels - Scratch & Dent - Small / (L) Rear Fender, Molding - Scratch & Dent - Small / Bonnet, Headlight - Scratch & Dent - Small / Front Bumper, Grille, Lamps - Scratch & Dent - Large / Roof - Scratch & Dent - Small / (L) Rear Door, Molding - Scratch - Minimal / Trunk Hood, Rear Gate - Scratch - Minimal / (R) Step, In-panel, Side Spoiler - Dent - Minimal
