BLUE-T VEHICLE GRADING SYSTEM

Grading Report

Date & Time: 03, Dec, 2024 17:37

Make	Toyota	**Model**	Vios
YOM	2021	**Mileage**	44,607
Registration No.	CBM6767	**Chassis No.**	PA1B18F32M4145582
CC	1.3	**Transmission**	CVT
Fuel Type	Gas	**Type of Body**	Sedan
Colour	BLACKISH RED MICA

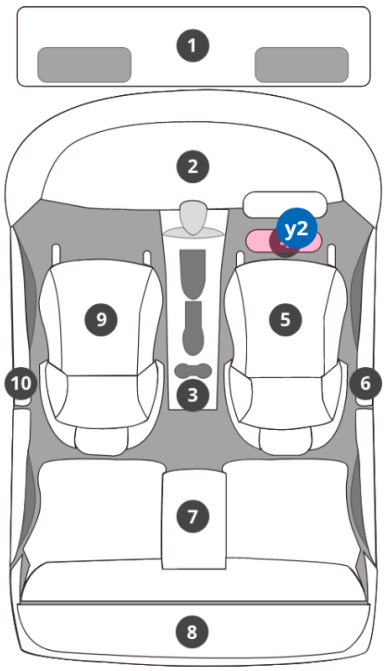
Interior Evaluation : A	Exterior Evaluation : A

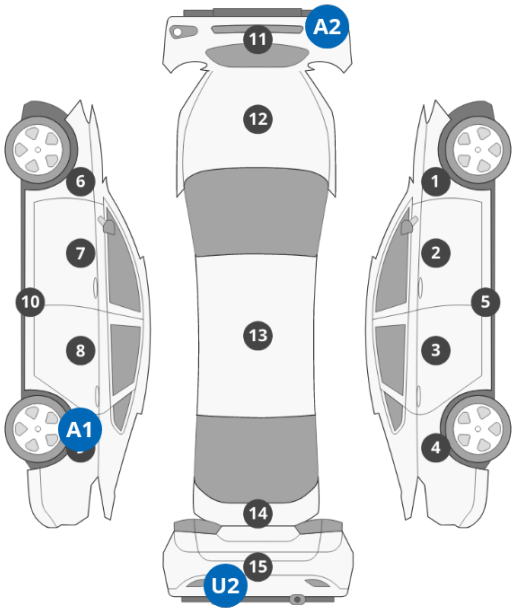
A : Scratch AU : Scratch & Dent B : Modified C : Corrosion G : Stone chip P : Faded S : Rust SC : Rust & Corrosion U : Dent X : Defective Y : Crack, Gap
Remarks (L) Front Floor Mat - Grime - Small	**Remarks** (R) Front Fender - Repair Traces - Yes / Bonnet - Repair Traces - Yes / Front Bumper, Grille, Lamps - Scratch - Small / Rear Bumper, Lamps, Panels - Dent - Small / (L) Rear Fender, Molding - Scratch - Minimal
Frame Evaluation : A	**Functional Evaluation : A**
Remarks Defects not found	**Remarks** Reverse Camera - N/A - Yes / Spare Key - Issue - Unexist

Inspector Notes
with spare tire and jack/warranty booklets/no tools/hairline scratches around the vehicle
