BLUE-T VEHICLE GRADING SYSTEM

# Grading Report

**Date & Time: 03, Dec, 2024 15:28**

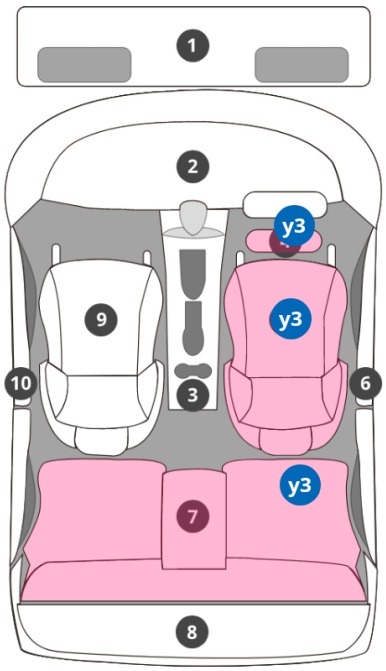
| Interior Evaluation : B | Exterior Evaluation : B |
|---|---|
| **Remarks**<br>Mat Other - Grime - Medium / (R) Front Seat - Grime - Medium / Rear Seat - Grime - Medium | **Remarks**<br>(R) Front Fender - Repair Traces - Yes / (R) Front Fender, Molding - Dent - Small / (R) Front Door, Molding - Scratch - Minimal / (R) Rear Door, Molding - Scratch - Minimal / (L) Rear Fender, Molding - Scratch - Minimal / Front Bumper, Grille, Lamps - Crack, Gap - Medium / Roof - Dent - Minimal / Trunk Hood, Rear Gate - Scratch & Dent - Small |
