BLUE-T VEHICLE GRADING SYSTEM

Grading Report

Make	Toyota	**Model**	Vios
YOM	2021	**Mileage**	37,041
Registration No.	NGO9432	**Chassis No.**	PA1B18F34M4137001
CC	1.3	**Transmission**	CVT
Fuel Type	Gas	**Type of Body**	Sedan
Colour	Blue

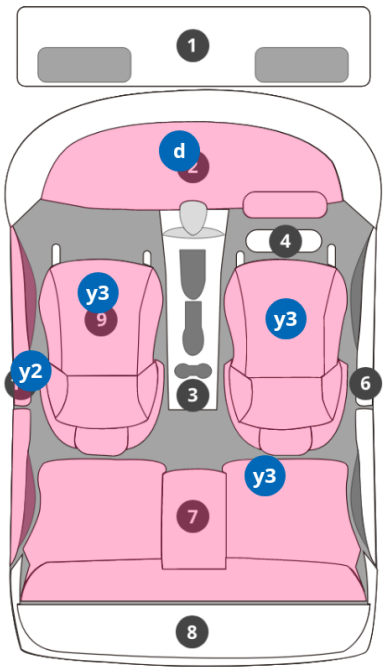
Interior Evaluation : B	Exterior Evaluation : C

a : Cut, Fray d : Loose, Deformed k : Animal Hair s : Smell t : Cigarette Burns x : Defective y : Stain

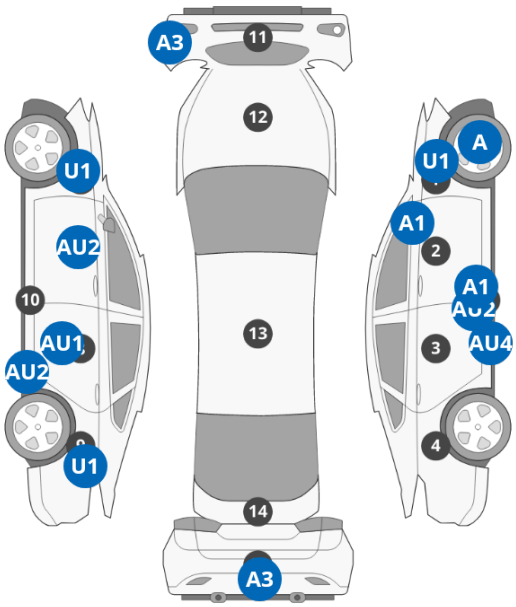
A : Scratch AU : Scratch & Dent B : Modified C : Corrosion G : Stone chip P : Faded S : Rust SC : Rust & Corrosion U : Dent X : Defective Y : Crack, Gap
Remarks Dashboard - Traces of Adhesive Tape - Yes / (R) Front Seat - Grime - Medium / Rear Seat - Grime - Medium / (L) Front Seat - Grime - Medium / (L) Front Trim - Grime - Small	**Remarks** (R) Front Fender, Molding - Dent - Minimal / (R) Front Tyre - Crack, Cut - Yes / (R) Mirror - Scratch - Minimal / (R) Rear Door, Molding - Scratch & Dent - Small / (R) Step, In-panel, Side Spoiler - Scratch & Dent - Large / (R) Front Door, Molding - Scratch - Minimal / (L) Front Fender, Molding - Dent - Minimal / (L) Front Door, Molding - Scratch & Dent - Small / (L) Rear Door, Molding - Scratch & Dent - Minimal / (L) Step, In-panel, Side Spoiler - Scratch & Dent - Small / (L) Rear Fender, Molding - Dent - Minimal / Front Bumper, Grille, Lamps - Scratch - Medium / Rear Bumper, Lamps, Panels - Scratch - Medium
