BLUE-T VEHICLE GRADING SYSTEM

# Grading Report

**Date & Time: 03, Dec, 2024 08:04**

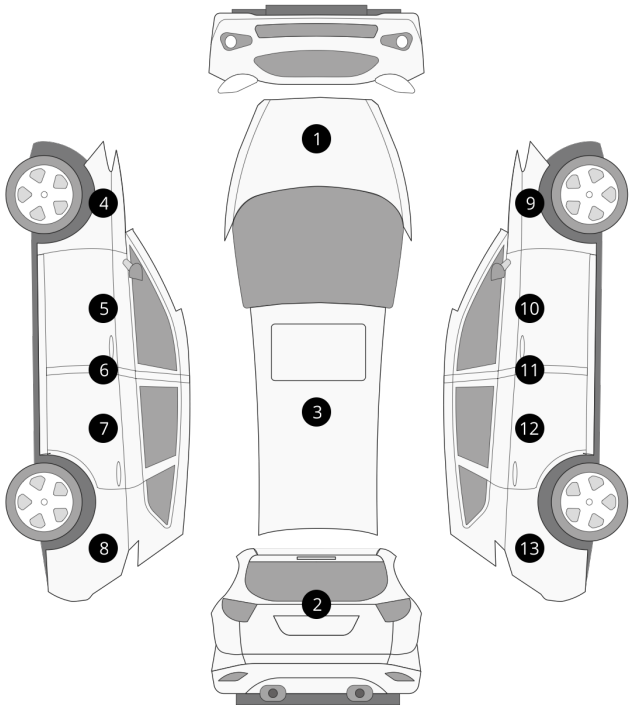
## Body / Panel Condition

| # | Area | Thickness(um) | | | |
| 1 | Bonnet | **108.6** | 110 | 103 | 113 |
| 2 | Boot Lid | **114.6** | 109 | 118 | 117 |
| 3 | Roof | **109.0** | 110 | 103 | 116/107 |
| 4 | Left Front Fender | **97.0** | 101 | 96 | 94 |
| 5 | Left Front Door | **101.8** | 96 | 97 | 113 |
| 7 | Left Rear Door | **108.3** | 116 | 106 | 103 |
| 8 | Left Back Panel | **111.6** | 110 | 115 | 110 |
| 9 | Right Front Fender | **98.7** | 96 | 101 | 99 |
| 10 | Right Front Door | **96.0** | 99 | 93 | 97 |
| 12 | Right Rear Door | **103.4** | 99 | 103 | 108 |
| 13 | Right Back Panel | **102.9** | 100 | 103 | 106 |

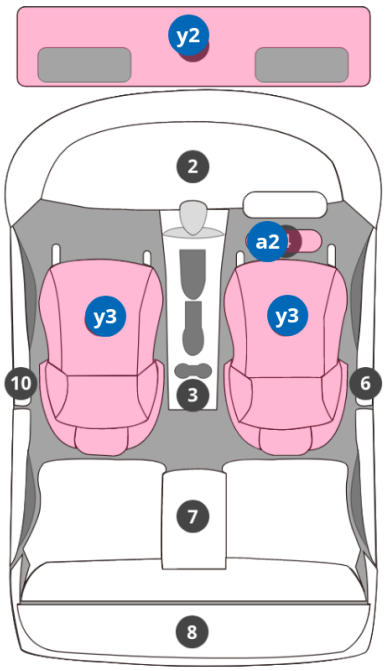
| Interior Evaluation : B | Exterior Evaluation : C |
| **Remarks**<br>(L) Front Floor Mat - Cut, Crack - Small / (L) Front Seat - Grime - Medium / Ceiling - Grime - Small / (R) Front Seat - Grime - Medium | **Remarks**<br>(R) Front Door, Molding - Scratch & Dent - Minimal / Trunk Hood, Rear Gate - Scratch & Dent - Small / Front Bumper, Grille, Lamps - Scratch & Dent - Medium / Roof - Repair mark - Yes / (R) Rear Fender, Molding - Scratch & Dent - Minimal / Rear Bumper, Lamps, Panels - Scratch - Small / (L) Mirror - Scratch - Small / (L) Front Door, Molding - Scratch - Small / (L) Rear Door, Molding - Repair mark - Yes / Bonnet, Headlight - Scratch - Small |

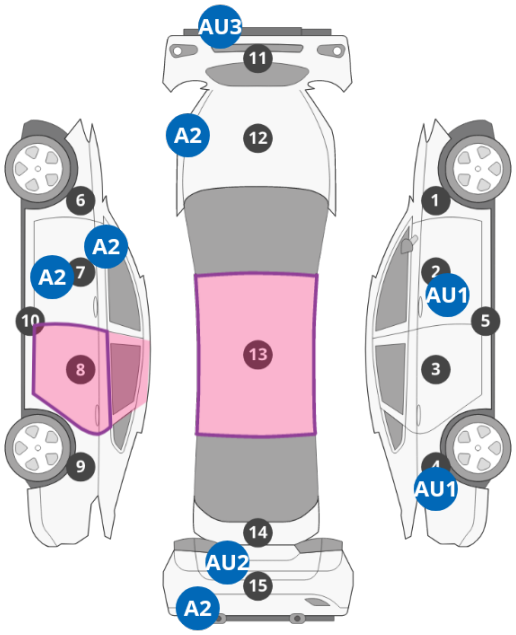
| Inspector Notes |
|---|
| with warranty booklet, user manual and tools. hairline scratches around the exterior. |
