BLUE-T VEHICLE GRADING SYSTEM

Grading Report

Make	Toyota	**Model**	Vios
YOM	2021	**Mileage**	46,146
Registration No.	NGU4446	**Chassis No.**	PA1B18F33M4137667
CC	1.3	**Transmission**	CVT
Fuel Type	Gas	**Type of Body**	Sedan
Colour	Blue

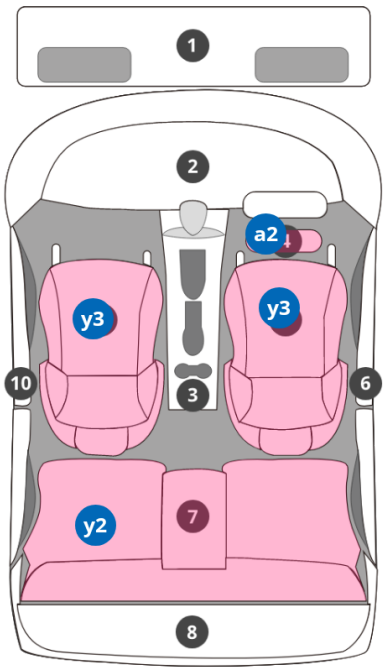
Interior Evaluation : B	Exterior Evaluation : C

A : Scratch AU : Scratch & Dent B : Modified C : Corrosion G : Stone chip P : Faded S : Rust SC : Rust & Corrosion U : Dent X : Defective Y : Crack, Gap
Remarks (L) Front Floor Mat - Cut, Crack - Small / (L) Front Seat - Grime - Medium / Rear Seat - Grime - Small / (R) Front Seat - Grime - Medium	**Remarks** (R) Front Fender - Repair Traces - Yes / (L) Front Fender - Repair Traces - Yes / (R) Rear Fender - Repair Traces - Yes / (R) Rear Fender - Replaced - Yes / Trunk Hood, Rear Gate - Scratch & Dent - Small / (L) Front Door, Molding - Scratch - Small / (L) Rear Door, Molding - Dent - Small / (R) Front Fender, Molding - Scratch & Dent - Minimal / Front Bumper, Grille, Lamps - Scratch & Dent - Small / Rear Bumper, Lamps, Panels - Scratch & Dent - Large

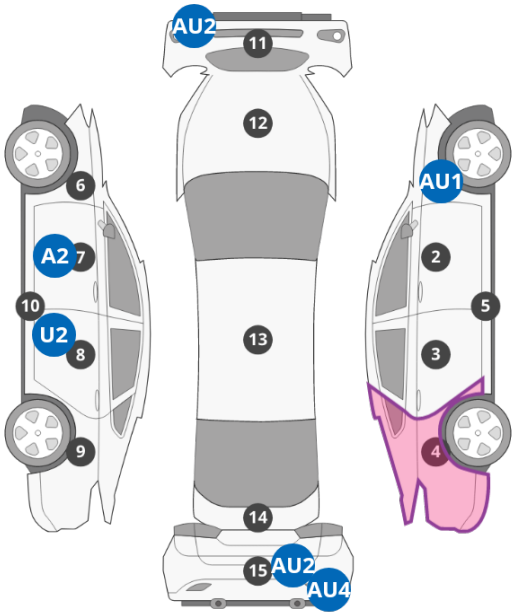
siwrlmarks and hairline scratches around the exterior. without warranty booklet and tools. with user manual. cable of dashcam left in the vehicle.
