BLUE-T VEHICLE GRADING SYSTEM

Grading Report

Make	Toyota	**Model**	Vios
YOM	2021	**Mileage**	21,632
Registration No.	DAV9684	**Chassis No.**	PA1B18F31M4155391
CC	1.3	**Transmission**	CVT
Fuel Type	Gas	**Type of Body**	Sedan
Colour	Silver

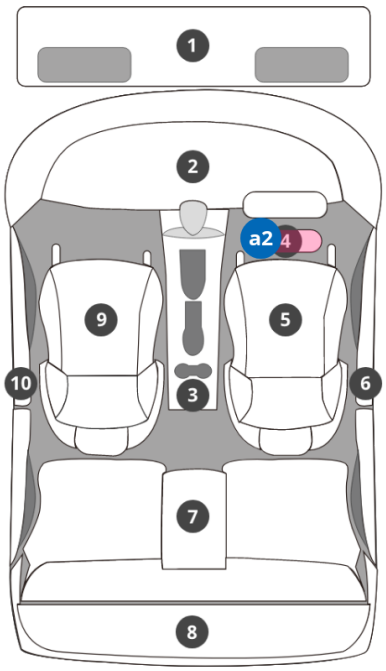
Interior Evaluation : A	Exterior Evaluation : B

A : Scratch AU : Scratch & Dent B : Modified C : Corrosion G : Stone chip P : Faded S : Rust SC : Rust & Corrosion U : Dent X : Defective Y : Crack, Gap
Remarks (L) Front Floor Mat - Cut, Crack - Small	**Remarks** Rear Bumper, Lamps, Panels - Scratch - Medium / Front Bumper, Grille, Lamps - Scratch - Medium / (R) Rear Door, Molding - Dent - Minimal / (L) Front Door, Molding - Dent - Minimal
Frame Evaluation : A	**Functional Evaluation : B**
Remarks Defects not found	**Remarks** Battery - Weak - Yes / Reverse Camera - N/A - Yes / Spare Key - Issue - Unexist

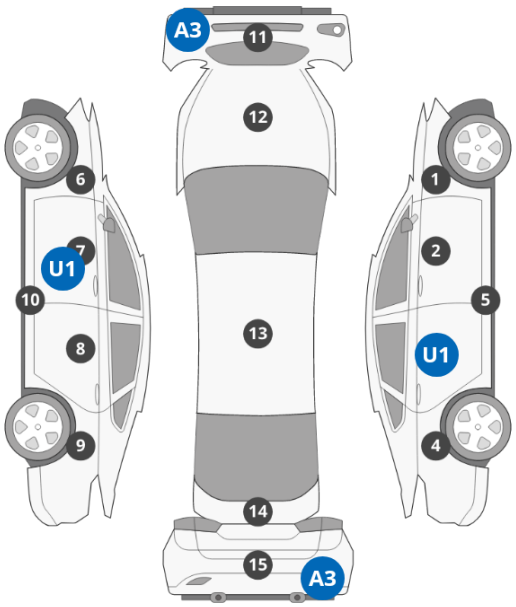
Inspector Notes
hairline scratches around the exterior.
