BLUE-T VEHICLE GRADING SYSTEM

Grading Report

Make	Toyota	**Model**	Wigo
YOM	2023	**Mileage**	18,213
Registration No.	DBJ7191	**Chassis No.**	MHKAA1BC2PJ004334
CC	1.0	**Transmission**	CVT
Fuel Type	Gas	**Type of Body**	Hatchback
Colour	Gray

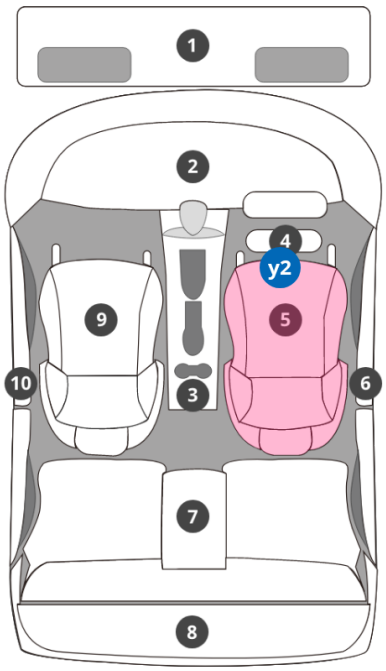
Interior Evaluation : A	Exterior Evaluation : C

a : Cut, Fray d : Loose, Deformed k : Animal Hair s : Smell t : Cigarette Burns x : Defective y : Stain

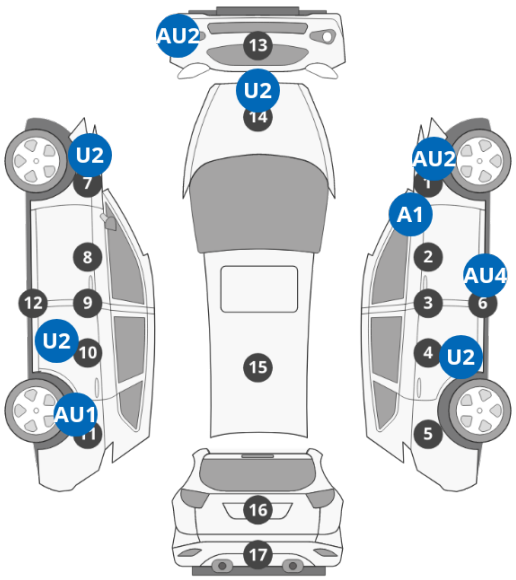
A : Scratch AU : Scratch & Dent B : Modified C : Corrosion G : Stone chip P : Faded S : Rust SC : Rust & Corrosion U : Dent X : Defective Y : Crack, Gap
Remarks (R) Front Seat - Grime - Small	**Remarks** Bonnet, Headlight - Dent - Small / (R) Front Fender, Molding - Scratch & Dent - Small / Front Bumper, Grille, Lamps - Scratch & Dent - Small / (L) Front Fender, Molding - Dent - Small / (L) Rear Door, Molding - Dent - Small / (L) Rear Fender, Molding - Scratch & Dent - Minimal / (R) Rear Door, Molding - Dent - Small / (R) Step, In-panel, Side Spoiler - Scratch & Dent - Large / (R) Mirror - Scratch - Minimal
Frame Evaluation : A	**Functional Evaluation : A**
Remarks Defects not found	**Remarks** Defects not found
