BLUE-T VEHICLE GRADING SYSTEM

Grading Report

Make	Toyota	**Model**	Vios
YOM	2024	**Mileage**	16,675
Registration No.	NFS6715	**Chassis No.**	PA1B18F32P4236887
CC	1.3	**Transmission**	CVT
Fuel Type	Gas	**Type of Body**	Sedan
Colour	White

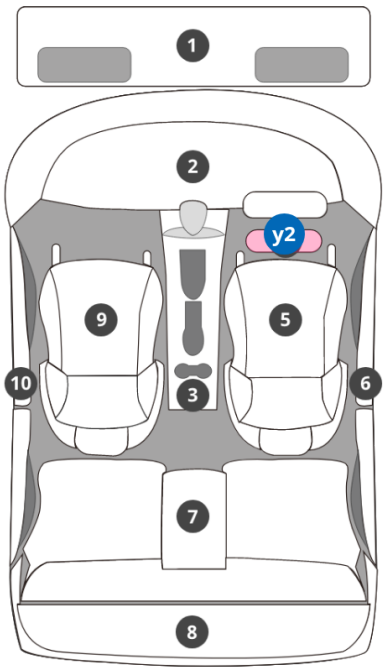
Interior Evaluation : A	Exterior Evaluation : A

A : Scratch AU : Scratch & Dent B : Modified C : Corrosion G : Stone chip P : Faded S : Rust SC : Rust & Corrosion U : Dent X : Defective Y : Crack, Gap
Remarks (L) Front Floor Mat - Grime - Small	**Remarks** (R) Front Door - Repair Traces - Yes / (R) Front Fender - Repair Traces - Yes / Bonnet - Repair Traces - Yes / Trunk Hood, Rear Gate - Repair Traces - Yes / (R) Rear Fender - Repair Traces - Yes / (R) Rear Door - Repair Traces - Yes / Roof - Repair Traces - Yes / Front Bumper, Grille, Lamps - Scratch - Small / (R) Front Fender, Molding - Dent - Small / (R) Step, In-panel, Side Spoiler - Dent - Small / (L) Front Wheel, Cover - Scratch, Corrosion - Small / (R) Front Wheel, Cover - Scratch, Corrosion - Small
Frame Evaluation : A	**Functional Evaluation : A**
