BLUE-T VEHICLE GRADING SYSTEM

Grading Report

Make	Toyota	**Model**	Vios
YOM	2022	**Mileage**	18,591
Registration No.	DAQ8791	**Chassis No.**	PA1B18F37N4179812
CC	1.3	**Transmission**	CVT
Fuel Type	Gas	**Type of Body**	Sedan
Colour	Black

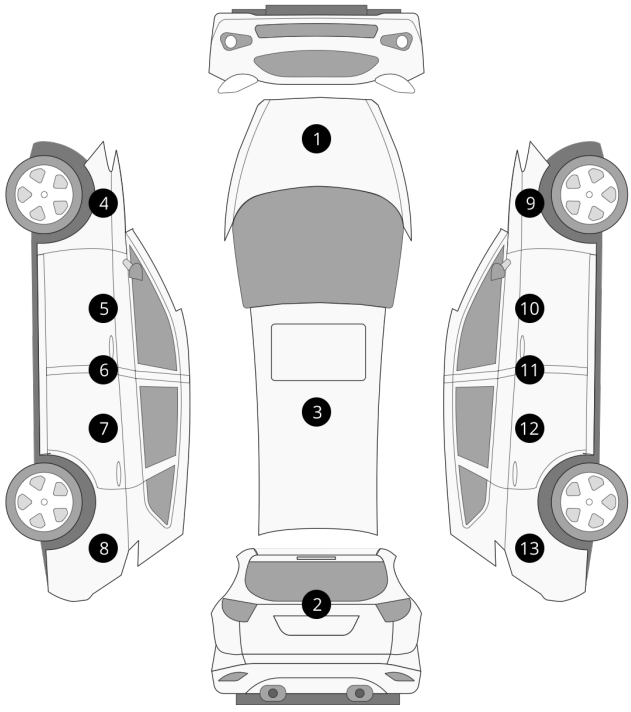
Body / Panel Condition

#	Area	Thickness(um)			
		Average	Value1	Value2	Value3/4
1	Bonnet	**110.3**	119	102	110
2	Boot Lid	**114.0**	126	104	112
3	Roof	**97.2**	100	96	95/98
4	Left Front Fender	**100.9**	98	102	103
5	Left Front Door	**112.6**	110	118	110
6	Center Panel Left				
7	Left Rear Door	**110.0**	114	107	109
8	Left Back Panel	**113.6**	136	105	100
9	Right Front Fender	**93.8**	96	95	91
10	Right Front Door	**98.3**	104	95	96
11	Center Panel Right				
12	Right Rear Door	**98.6**	100	87	109
13	Right Back Panel	**99.0**	92	97	108

Overall Evaluation : B

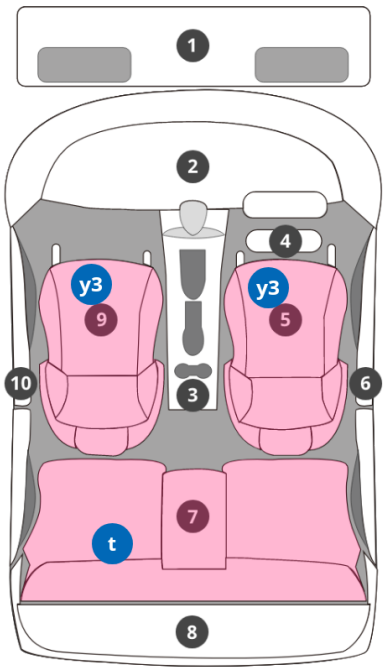
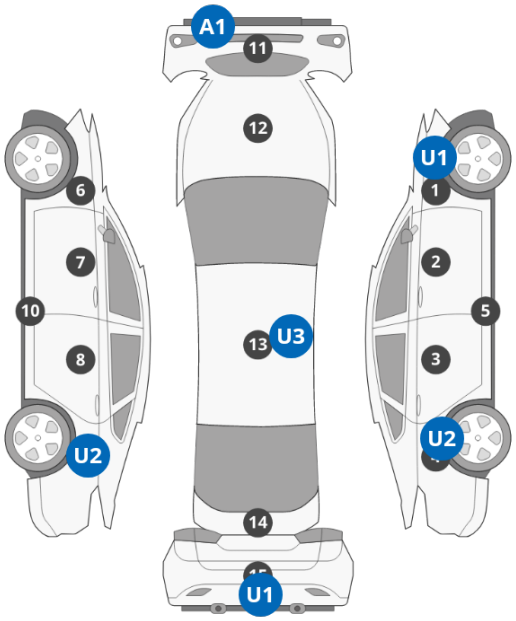
Interior Evaluation : C	Exterior Evaluation : B

a : Cut, Fray d : Loose, Deformed k : Animal Hair s : Smell t : Cigarette Burns x : Defective y : Stain	A : Scratch AU : Scratch & Dent B : Modified C : Corrosion G : Stone chip P : Faded S : Rust SC : Rust & Corrosion U : Dent X : Defective Y : Crack, Gap
Remarks (L) Front Seat - Grime - Medium / (R) Front Seat - Grime - Medium / Rear Seat - Cigarette Burns - Burnt, Hole	**Remarks** Rear Bumper, Lamps, Panels - Dent - Minimal / (L) Rear Fender, Molding - Dent - Small / (R) Rear Fender, Molding - Dent - Small / Roof - Dent - Medium / Front Bumper, Grille, Lamps - Scratch - Minimal / (R) Front Fender, Molding - Dent - Minimal
Frame Evaluation : A	**Functional Evaluation : A**
Remarks Defects not found	**Remarks** Spare Key - Issue - Unexist

Inspector Notes
no reverse camera/no spare tire/no tools and jack/no warranty booklets
