BLUE-T VEHICLE GRADING SYSTEM

Grading Report

Make	Toyota	**Model**	Vios
YOM	2023	**Mileage**	41,038
Registration No.	NIM5984	**Chassis No.**	PA1B18F3XP4213714
CC	1.3	**Transmission**	CVT
Fuel Type	Gas	**Type of Body**	Sedan
Colour	Silver

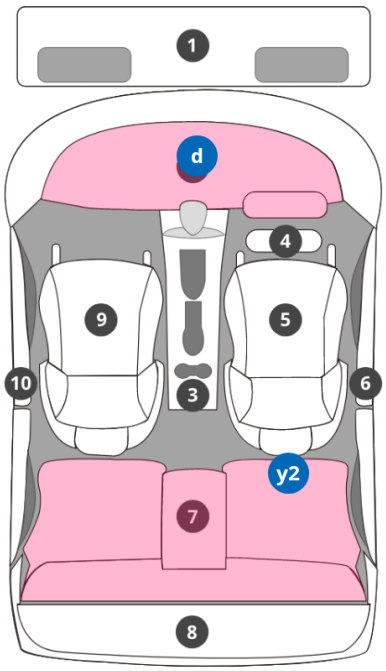
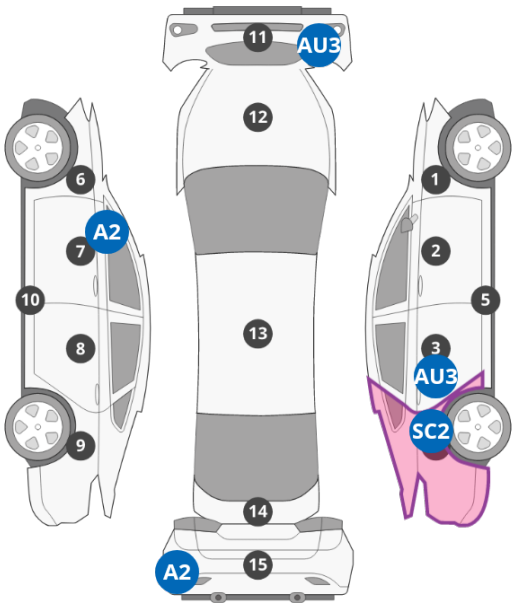
Interior Evaluation : A	Exterior Evaluation : B

A : Scratch AU : Scratch & Dent B : Modified C : Corrosion G : Stone chip P : Faded S : Rust SC : Rust & Corrosion U : Dent X : Defective Y : Crack, Gap
Remarks Dashboard - Traces of Adhesive Tape - Yes / Rear Seat - Grime - Small	**Remarks** (R) Step - Repair Traces - Yes / (R) Rear Fender - Repair Traces - Yes / (R) Rear Fender - Replaced - Yes / Front Bumper, Grille, Lamps - Scratch & Dent - Medium / (R) Rear Door, Molding - Scratch & Dent - Medium / (R) Rear Fender, Molding - Rust, Corrosion - Small / Rear Bumper, Lamps, Panels - Scratch - Small / (L) Mirror - Scratch - Small
Frame Evaluation : A	**Functional Evaluation : A**
Remarks Defects not found	**Remarks** Reverse Camera - N/A - Yes

Inspector Notes
hairline scratches around the exterior. without warranty booklet and user manual.
