BLUE-T VEHICLE GRADING SYSTEM

Grading Report

Make	Toyota	**Model**	Wigo
YOM	2021	**Mileage**	23,488
Registration No.	DAV5135	**Chassis No.**	MHKA4DF5FMJ055933
CC	1.0	**Transmission**	A/T
Fuel Type	Gas	**Type of Body**	Hatchback
Colour	Gray

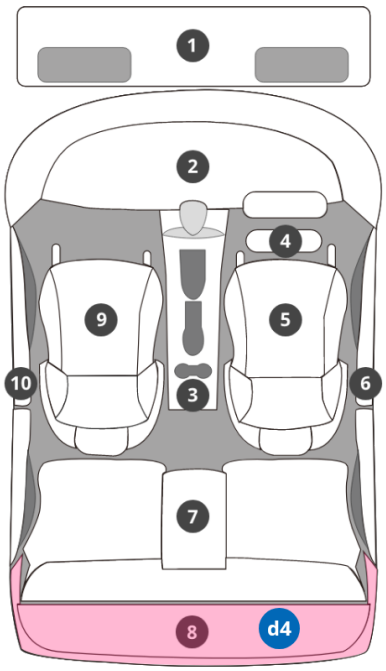
Interior Evaluation : C	Exterior Evaluation : A

a : Cut, Fray d : Loose, Deformed k : Animal Hair s : Smell t : Cigarette Burns x : Defective y : Stain

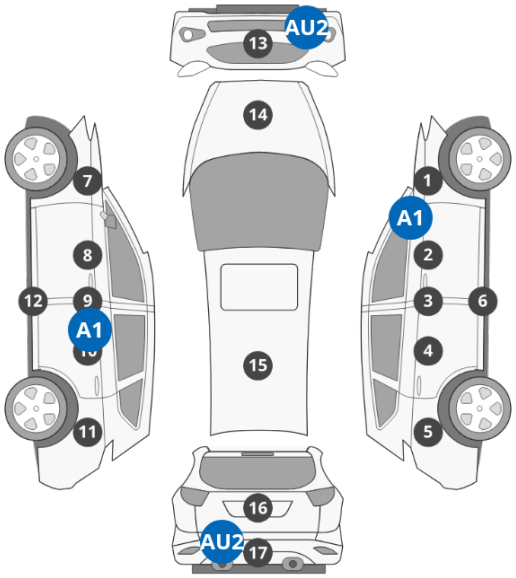
A : Scratch AU : Scratch & Dent B : Modified C : Corrosion G : Stone chip P : Faded S : Rust SC : Rust & Corrosion U : Dent X : Defective Y : Crack, Gap
Remarks Trunk Room - Loose, Deformed - Large	**Remarks** (L) Front Fender - Repair Traces - Yes / (L) Rear Door, Molding - Scratch - Minimal / Rear Bumper, Lamps, Panels - Scratch & Dent - Small / (R) Mirror - Scratch - Minimal / Front Bumper, Grille, Lamps - Scratch & Dent - Small
Frame Evaluation : A	**Functional Evaluation : A**
Remarks Defects not found	**Remarks** Spare Key - Issue - Unexist

Inspector Notes
Left front fender was replace
