BLUE-T VEHICLE GRADING SYSTEM

Grading Report

Make	Toyota	**Model**	Vios
YOM	2021	**Mileage**	25,511
Registration No.	NGR5690	**Chassis No.**	PA1B18F3XL4129192
CC	1.3	**Transmission**	CVT
Fuel Type	Gas	**Type of Body**	Sedan
Colour	Silver

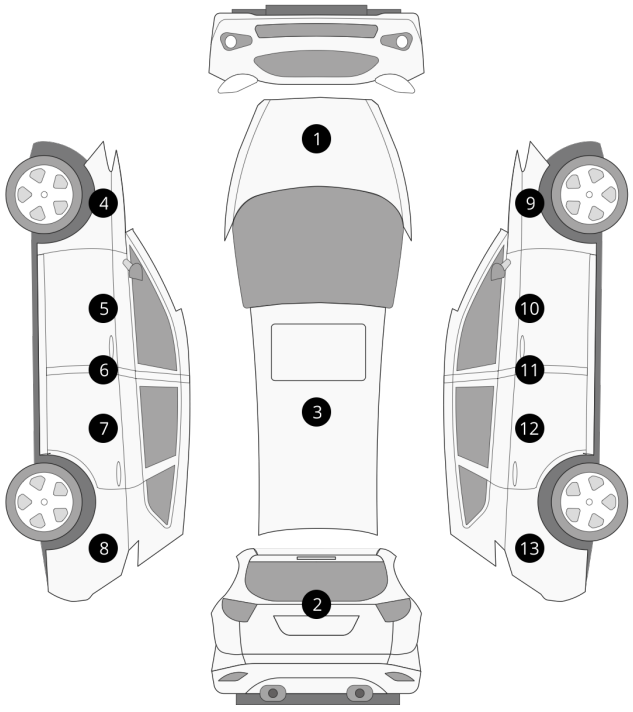
Body / Panel Condition

#	Area	Thickness(um)			
		Average	Value1	Value2	Value3/4
1	Bonnet	**106.4**	94	120	105
2	Boot Lid	**101.8**	100	100	106
3	Roof	**90.7**	92	88	89/94
4	Left Front Fender	**87.6**	90	80	94
5	Left Front Door	**91.8**	90	95	91
6	Center Panel Left				
7	Left Rear Door	**94.8**	102	96	86
8	Left Back Panel	**98.0**	102	99	94
9	Right Front Fender	**91.7**	94	89	92
10	Right Front Door	**92.7**	90	94	95
11	Center Panel Right				
12	Right Rear Door	**90.3**	86	90	95
13	Right Back Panel	**94.7**	92	94	99

Overall Evaluation : B

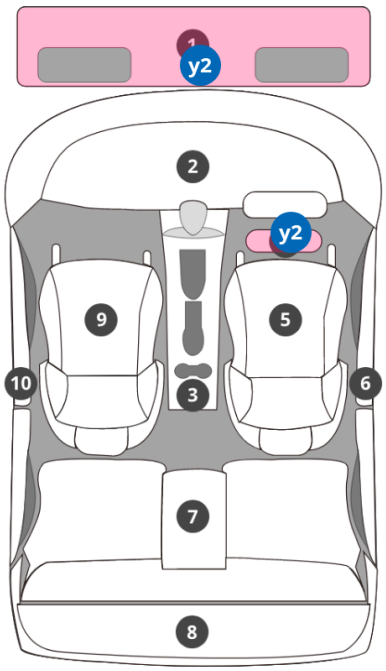
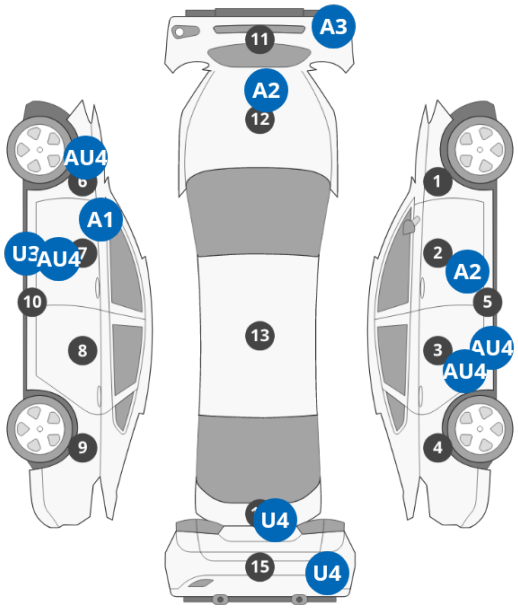
Interior Evaluation : A	Exterior Evaluation : E

a : Cut, Fray d : Loose, Deformed k : Animal Hair s : Smell t : Cigarette Burns x : Defective y : Stain	A : Scratch AU : Scratch & Dent B : Modified C : Corrosion G : Stone chip P : Faded S : Rust SC : Rust & Corrosion U : Dent X : Defective Y : Crack, Gap
Remarks (L) Front Floor Mat - Grime - Small / Ceiling - Grime - Small	**Remarks** Rear Bumper, Lamps, Panels - Dent - Large / Trunk Hood, Rear Gate - Dent - Large / (L) Step, In-panel, Side Spoiler - Dent - Medium / (L) Front Door, Molding - Scratch & Dent - Large / (L) Front Fender, Molding - Scratch & Dent - Large / Front Bumper, Grille, Lamps - Scratch - Medium / (R) Step, In-panel, Side Spoiler - Scratch & Dent - Large / (R) Rear Door, Molding - Scratch & Dent - Large / (R) Front Door, Molding - Scratch - Small / Bonnet, Headlight - Scratch - Small / (L) Mirror - Scratch - Minimal

Frame Evaluation : A	**Functional Evaluation : A**
Remarks Defects not found	**Remarks** Spare Key - Issue - Unexist

Inspector Notes
with spare tire and jack/fuel lid loose/no tools and warranty booklets/ no reverse camera
