## General Information

<b>Make</b>	Toyota	<b>Model</b>	Hiace
<b>YOM</b>	2025	<b>Odo Meter Reading</b>	3
<b>Registration No.</b>	DA667B	<b>Chassis No.</b>	JTFPA9AP7S8055276
<b>CC</b>	2.8	<b>Transmission</b>	M/T
<b>Fuel Type</b>	Diesel	<b>Type of Body</b>	Van
<b>Colour</b>	White

## Body / Panel Condition

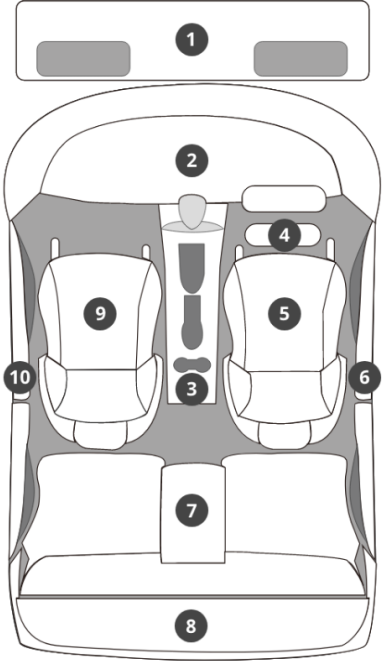
<b>Interior Evaluation :</b> <span style="color: red; font-weight: bold; font-size: 1.2em;">A</span>	<b>Exterior Evaluation :</b> <span style="color: red; font-weight: bold; font-size: 1.2em;">B</span>

<b>Remarks</b> Defects not found	<b>Remarks</b> Defects not found
