## General Information

<b>Make</b>	Toyota	<b>Model</b>	Veloz
<b>YOM</b>	2024	<b>Mileage</b>	7,286
<b>Registration No.</b>	EAJ1247	<b>Chassis No.</b>	MHFAB1BY3P3069284
<b>CC</b>	1.5	<b>Transmission</b>	CVT
<b>Fuel Type</b>	Gas	<b>Type of Body</b>	SUV
<b>Colour</b>	Purple

## Body / Panel Condition

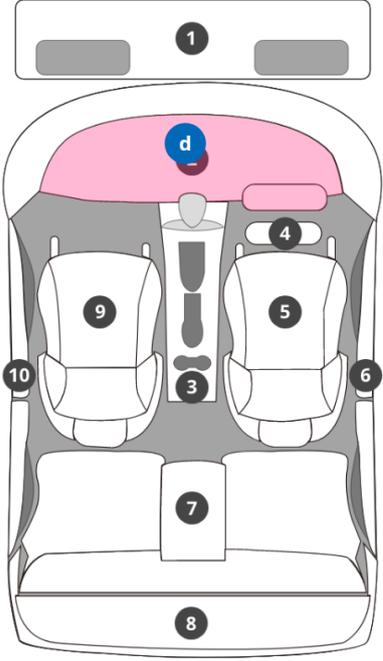
<b>Interior Evaluation :</b> <span style="color: red; font-weight: bold; font-size: 1.2em;">A</span>	<b>Exterior Evaluation :</b> <span style="color: red; font-weight: bold; font-size: 1.2em;">C</span>

<p><b>Remarks</b> Defects not found</p>	<p><b>Remarks</b> Defects not found</p>
