## General Information

Date & Time: 05, Sep, 2025 09:50

<b>Make</b>	Toyota	<b>Model</b>	Raize
<b>YOM</b>	2022	<b>Odo Meter Reading</b>	45,023
<b>Registration No.</b>	NFK9326	<b>Chassis No.</b>	MHKAA1BA3NJ037385
<b>CC</b>	1.0	<b>Transmission</b>	CVT
<b>Fuel Type</b>	Gas	<b>Type of Body</b>	SUV
<b>Colour</b>	White

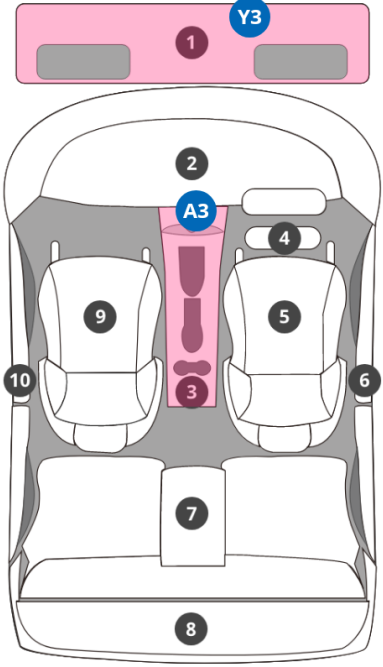
<b>Interior Evaluation :</b> <span style="float: right;"><b>B</b></span>	<b>Exterior Evaluation :</b> <span style="float: right;"><b>C</b></span>

<p><b>a</b> : Cut, Fray <b>d</b> : Loose, Deformed <b>k</b> : Animal Hair <b>s</b> : Smell <b>t</b> : Cigarette Burns <b>x</b> : Defective <b>y</b> : Stain</p>
