## General Information

| Make | Toyota | Model | Wigo |
| YOM | 2024 | Mileage | 9,146 |
| Registration No. | DBN7594 | Chassis No. | MHKAA1BC9PJ008445 |

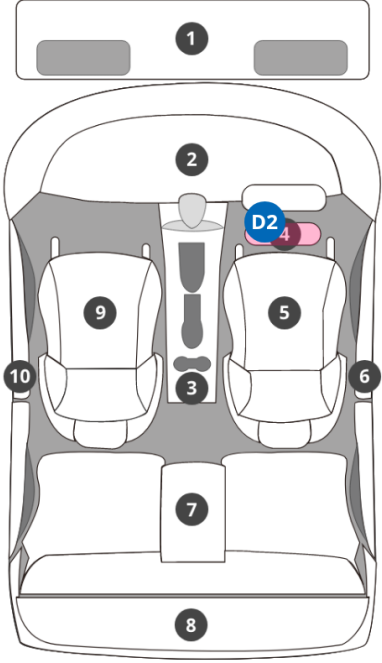
| Interior Evaluation : <b>A</b> | Exterior Evaluation : <b>B</b> |
|---|---|
| <b>Remarks</b><br>(L) Front Floor Mat - Worked - Small | <b>Remarks</b><br>(R) Front Fender, Molding - Dent - Small / Front Bumper, Grille, Lamps - Scratch - Small / (L) Front Fender, Molding - Scratch - Minimal / (L) Step, In-panel, Side Spoiler - Scratch - Small / (L) Front Door, Molding - Scratch - Minimal / Rear Bumper, Lamps, Panels - Scratch - Small / (R) Step, In-panel, Side Spoiler - Scratch - Small |
