## General Information

| Make | Toyota | Model | Avanza |
| YOM | 2023 | Mileage | 26,472 |
| Registration No. | CBK8595 | Chassis No. | MHFAA1BY9N0010578 |

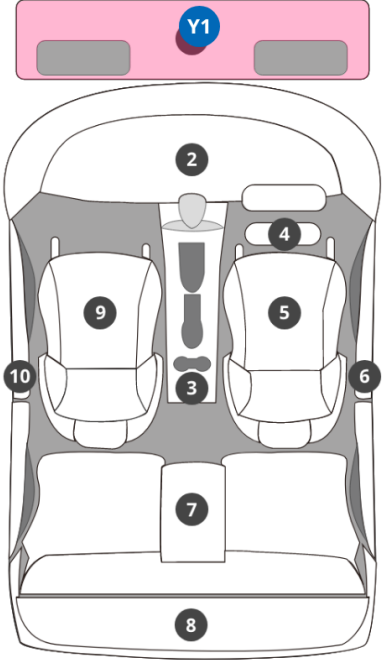
| <b>Interior Evaluation :</b> <span style="color: red; font-weight: bold;">A</span> | <b>Exterior Evaluation :</b> <span style="color: red; font-weight: bold;">C</span> |
| <b>Remarks</b><br>Ceiling - Grime - Minimal | <b>Remarks</b><br>Trunk Hood, Rear Gate - Repair Traces - Yes / (R) Front Fender, Molding - Scratch - Medium / (R) Front Door, Molding - Scratch - Small / (R) Rear Door, Molding - Scratch - Small / (R) Rear Fender, Molding - Scratch - Small / Rear Bumper, Lamps, Panels - Scratch - Small / (L) Rear Fender, Molding - Scratch & Dent - Small / (L) Rear Door, Molding - Scratch - Medium / (L) Front Door, Molding - Scratch - Medium / Front Bumper, Grille, Lamps - Scratch - Medium |
