## General Information

| Make | Toyota | Model | Veloz |
| Registration No. | DBM2331 | Chassis No. | MHFAB1BY4P3082190 |

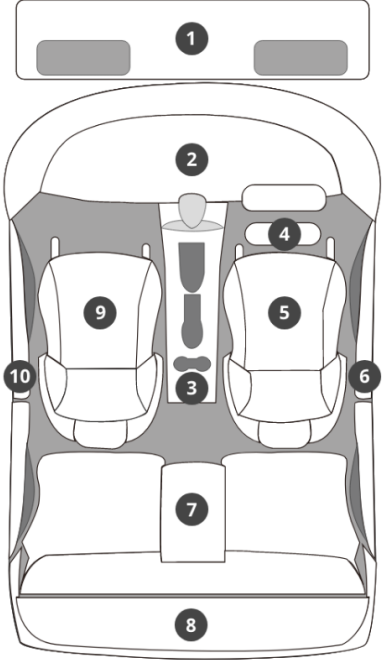
| <b>Remarks</b><br>Defects not found | <b>Remarks</b><br>(R) Mirror - Scratch - Minimal / (R) Front Door, Molding - Scratch - Minimal / (R) Rear Door, Molding - Scratch - Medium / (R) Rear Fender, Molding - Scratch - Small / Trunk Hood, Rear Gate - Scratch - Minimal / Rear Bumper, Lamps, Panels - Scratch - Medium / (L) Rear Fender, Molding - Scratch - Small / (L) Rear Door, Molding - Scratch - Small / (L) Front Door, Molding - Scratch - Minimal |
