## General Information

| Make | Toyota | Model | Vios |
| YOM | 2024 | Mileage | 9,578 |

## Body / Panel Condition

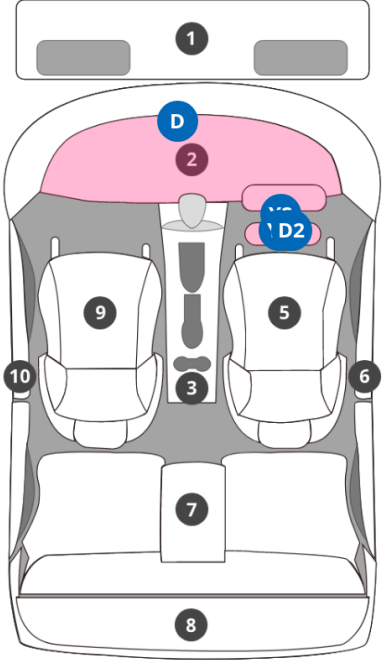
| Interior Evaluation : <b>A</b> | Exterior Evaluation : <b>B</b> |
| <p><b>Remarks</b><br/>Mat Other - Grime - Small / (L) Front Floor Mat - Grime - Small / (L) Front Floor Mat - Worked - Small / Dashboard - Traces of Adhesive Tape - Yes</p> | <p><b>Remarks</b><br/>(R) Mirror - Scratch - Small / (R) Rear Door, Molding - Scratch - Small / Rear Bumper, Lamps, Panels - Scratch &amp; Dent - Medium / Roof - Scratch &amp; Dent - Medium / Front Bumper, Grille, Lamps - Scratch - Small</p> |
