## General Information

| Make | Toyota | Model | Vios |
| YOM | 2024 | Mileage | 14,911 |
| Registration No. | NKE9970 | Chassis No. | PA1B18F38R4257648 |

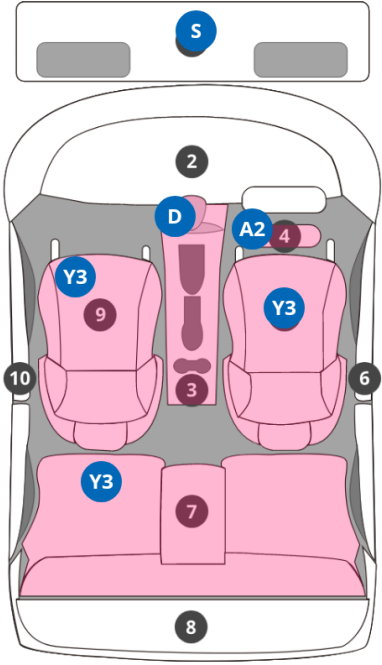
| Interior Evaluation : <b>B</b> | Exterior Evaluation : <b>B</b> |
|---|---|
| <p><b>a</b> : Cut, Fray <b>d</b> : Loose, Deformed <b>k</b> : Animal Hair <b>s</b> : Smell <b>t</b> : Cigarette Burns <b>x</b> : Defective <b>y</b> : Stain</p> | <p><b>A</b> : Scratch <b>AU</b> : Scratch &amp; Dent <b>B</b> : Modified <b>C</b> : Corrosion <b>G</b> : Stone chip <b>P</b> : Faded <b>S</b> : Rust <b>SC</b> : Rust &amp; Corrosion <b>U</b> : Dent <b>X</b> : Defective <b>Y</b> : Crack, Gap</p> |
| <p><b>Remarks</b></p> <p>Overall Interior - Smell - Yes / (R) Front Seat - Grime - Medium / Rear Seat - Grime - Medium / (L) Front Floor Mat - Cut, Crack - Small / Console, Switchs, Vents - Traces of Adhesive Tape - Yes / (L) Front Seat - Grime - Medium</p> | <p><b>Remarks</b></p> <p>(L) Front Fender, Molding - Scratch &amp; Dent - Medium / (L) Mirror - Scratch - Minimal / Front Bumper, Grille, Lamps - Scratch - Medium / (L) Front Door, Molding - Scratch - Small / (R) Front Door, Molding - Scratch - Medium / (R) Rear Door, Molding - Scratch &amp; Dent - Minimal</p> |
