## General Information

| Make | Toyota | Model | Vios |

## Body / Panel Condition

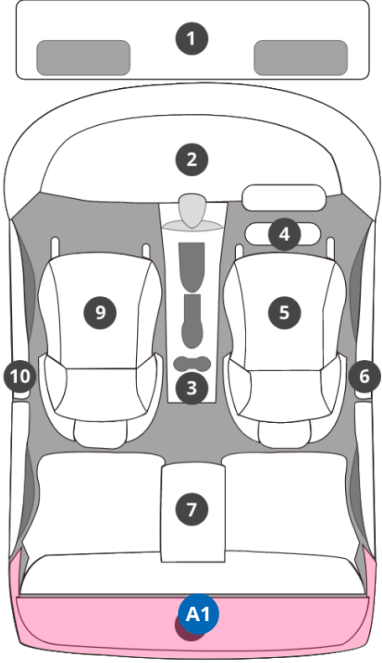
| Interior Evaluation : <span style="color: red;">A</span> | Exterior Evaluation : <span style="color: red;">C</span> |
| <b>Remarks</b><br>Trunk Room - Worn, Scratch, Cut, Crack - Minimal | <b>Remarks</b><br>(R) Rear Fender, Molding - Dent - Medium / Rear Bumper, Lamps, Panels - Scratch & Dent - Large / (L) Rear Fender, Molding - Scratch - Minimal / (L) Rear Door, Molding - Scratch - Minimal / (L) Front Door, Molding - Scratch - Minimal / (L) Mirror - Scratch - Minimal / (L) Front Fender, Molding - Scratch - Small / Bonnet, Headlight - Scratch - Minimal / Front Bumper, Grille, Lamps - Scratch - Small / (R) Front Fender, Molding - Scratch - Small / (R) Rear Door, Molding - Scratch - Small |
